Woodpecker Damage to Wooden Utility Poles.

Robert Louis Rumsey
Louisiana State University and Agricultural & Mechanical College

A Dissertation

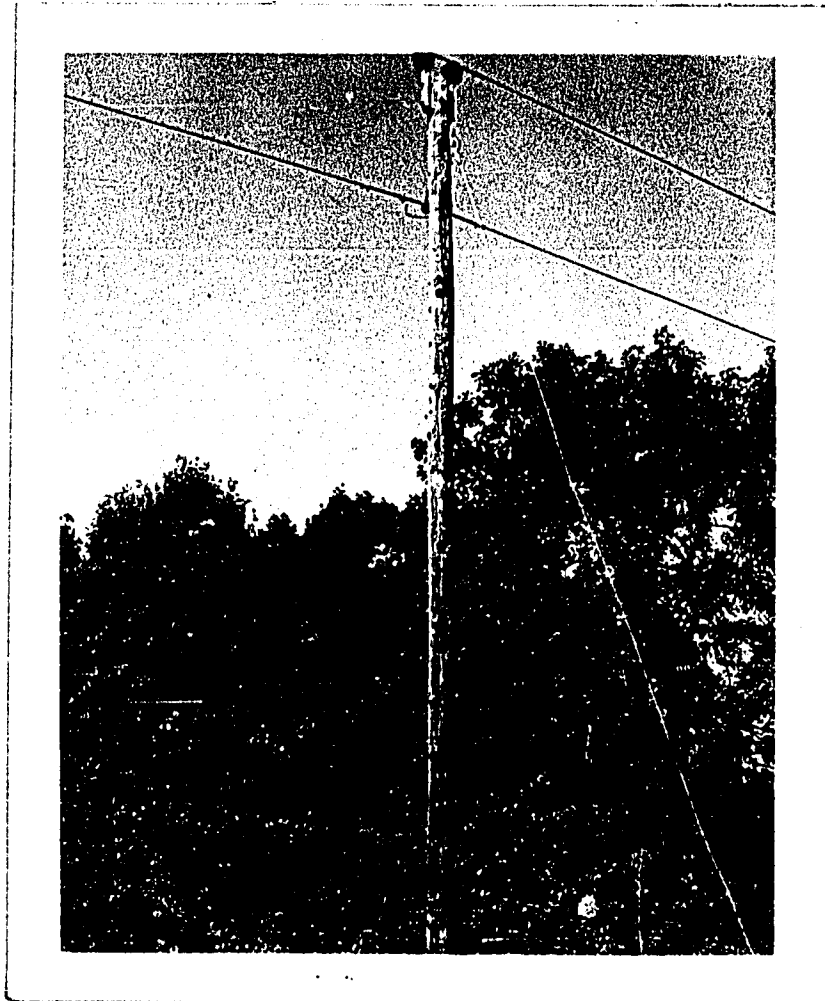
Figure 3. Test probes by Red-headed Woodpeckers are usually spherical and extend inward only, not downward. Some poles have several such probes. (Saline Wildlife Management Area, LaSalle Parish, Louisiana, 1967.)

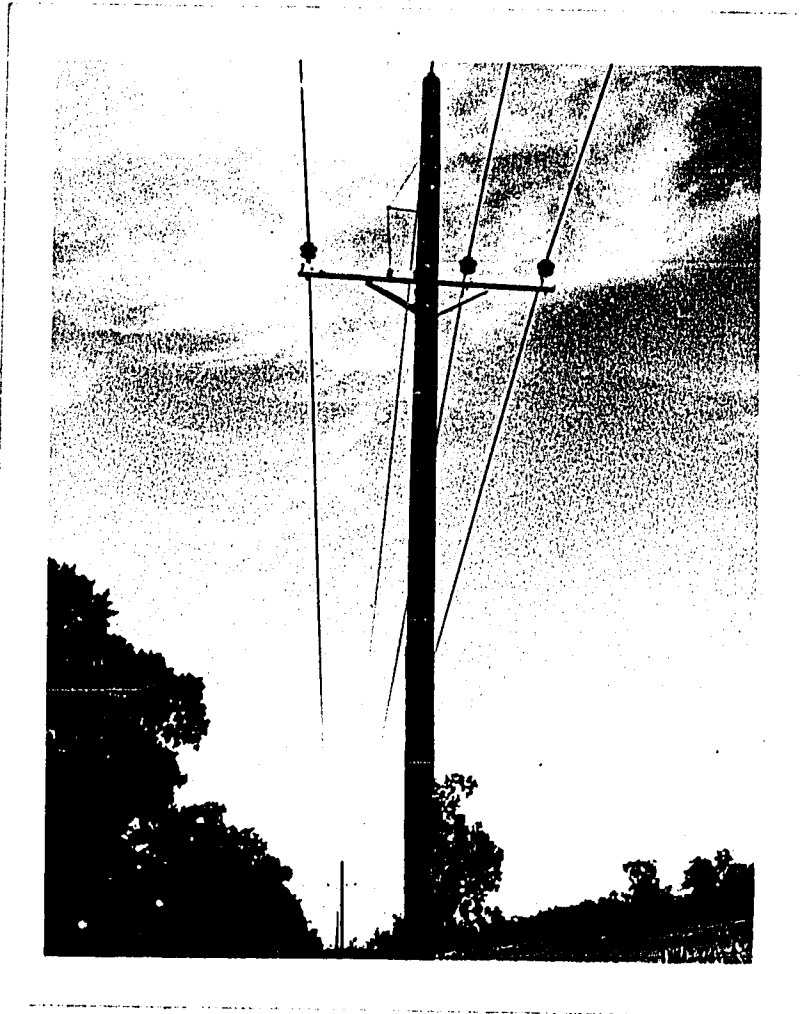
Figure 6. Eight strips of 19 gauge, 2 x 2 hardware cloth were used to wrap this pole. Although Pileated Woodpeckers have torn through, hardware cloth offers the best practical protection available. (Saline Wildlife Management Area, LaSalle Parish, Louisiana, 1970.)

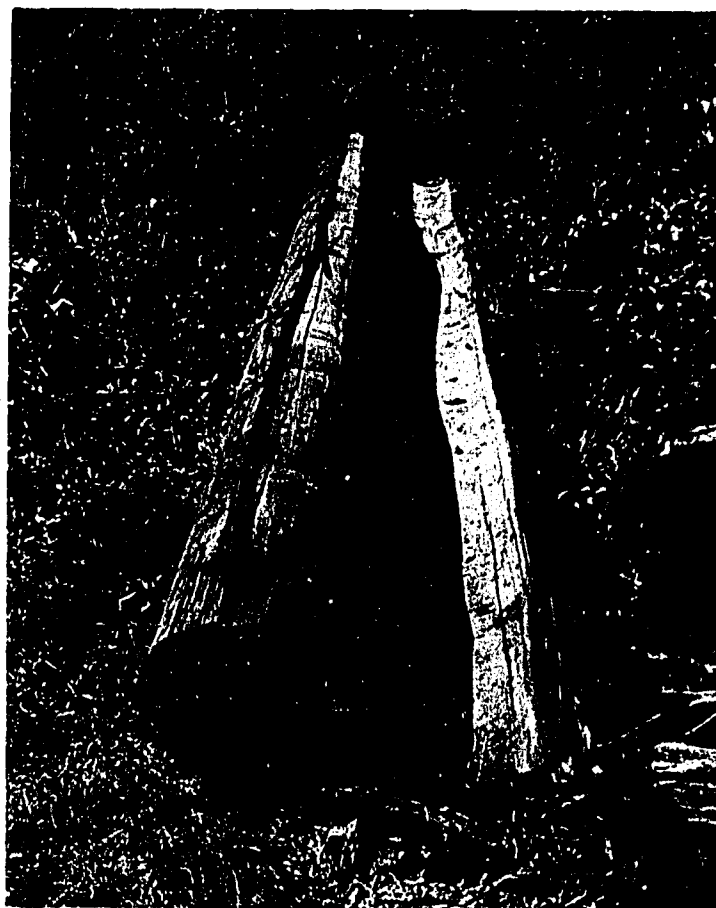
Figure 14. This 2-inch thick slab extending over half the length of the pole is probably the result of treatment-induced ring shake. (Saline Wildlife Management Area, LaSalle Parish, Louisiana, 1971.)

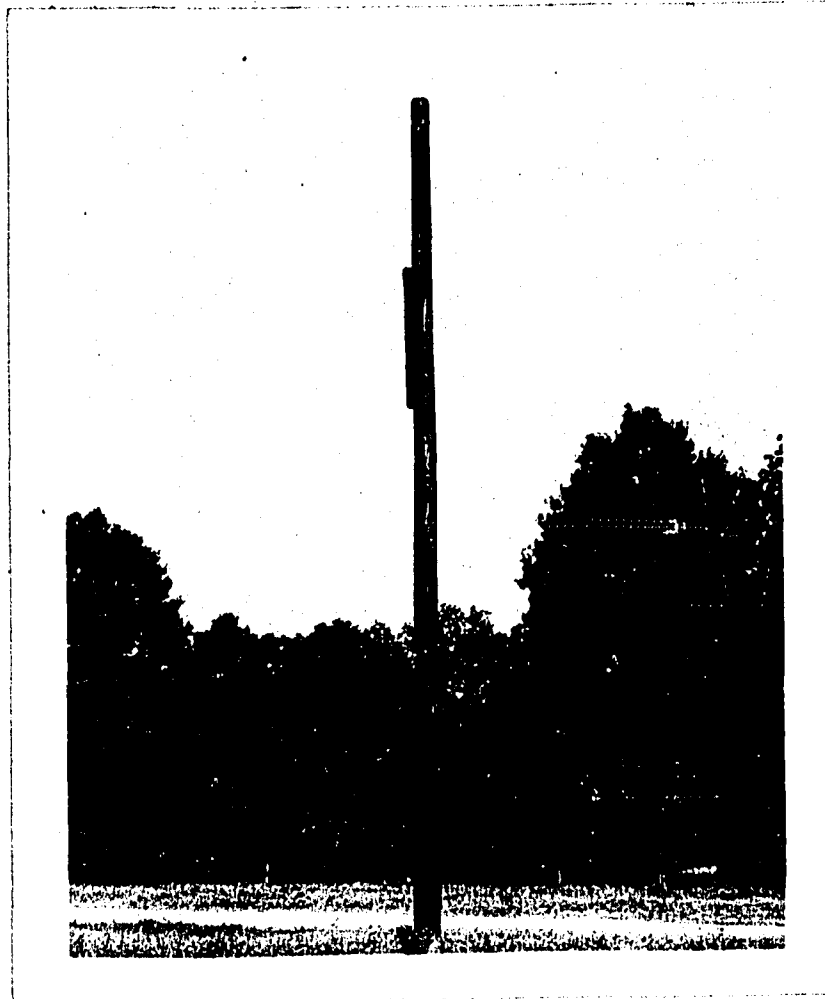
Figure 18. Hollow sections were used extensively by woodpeckers, but the birds also damaged the poles. (Saline Wildlife Management Area, LaSalle Parish, Louisiana, 1969.)
