Restoration success of backfilling canals in coastal Louisiana marshes

RESTORATION SUCCESS OF BACKFILLING
CANALS IN COASTAL LOUISIANA MARSHES

A Thesis

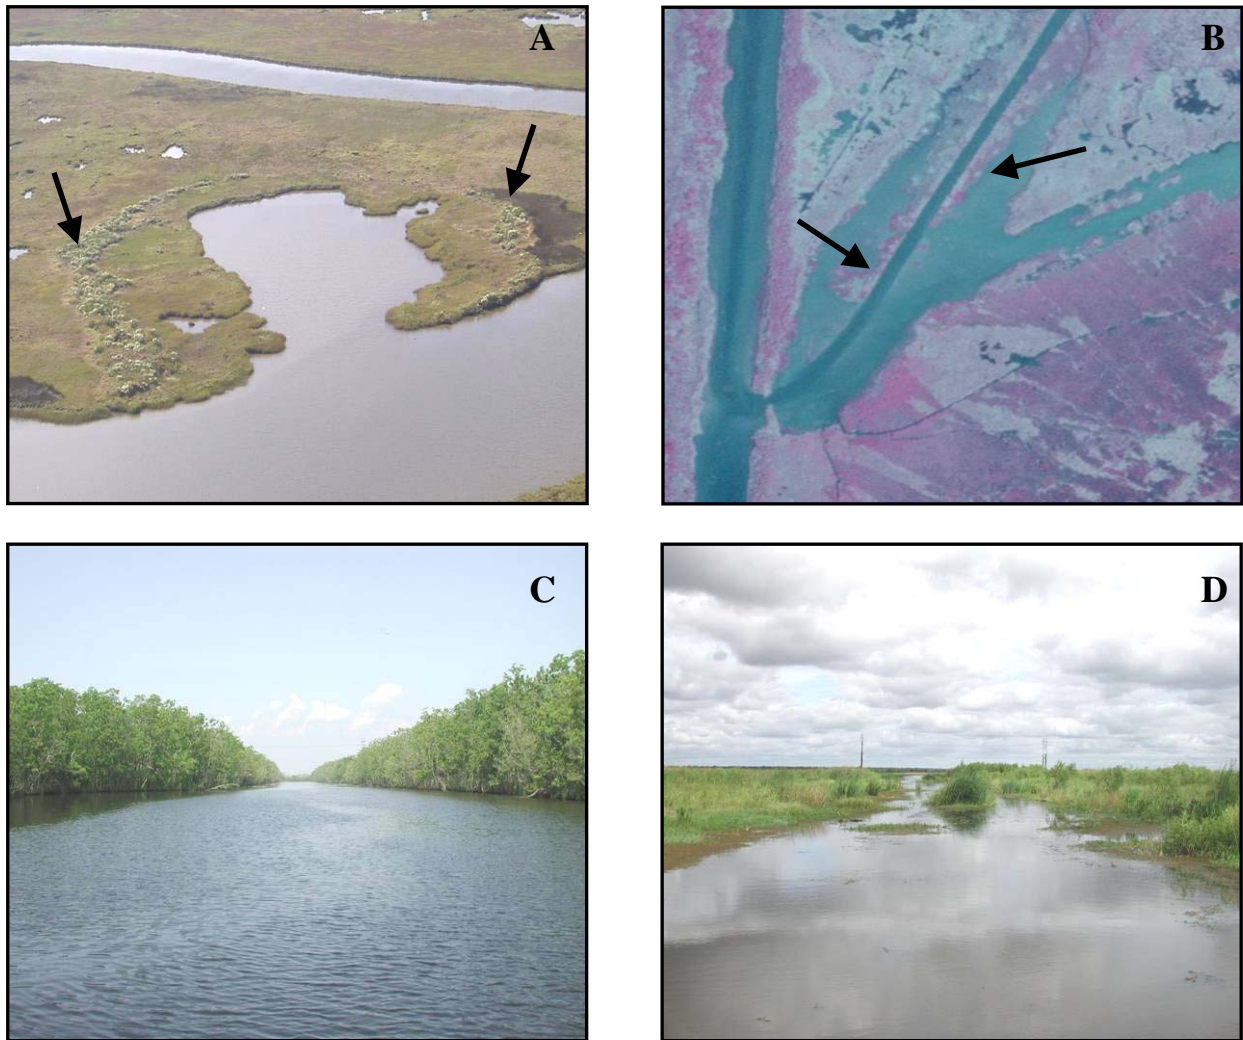
Figure 7. The Mosquito Bay backfilled canal (A), the arrows point to a rim of elevated spoil not reachable by the barge mounted dredge. A portion of the Pecan Island West backfilled canal (B), the arrows point to marsh building in the canal through over-bank flooding. A canal at Jean Lafitte National Park before (C) and two years after being backfilled with a marsh buggy (D).

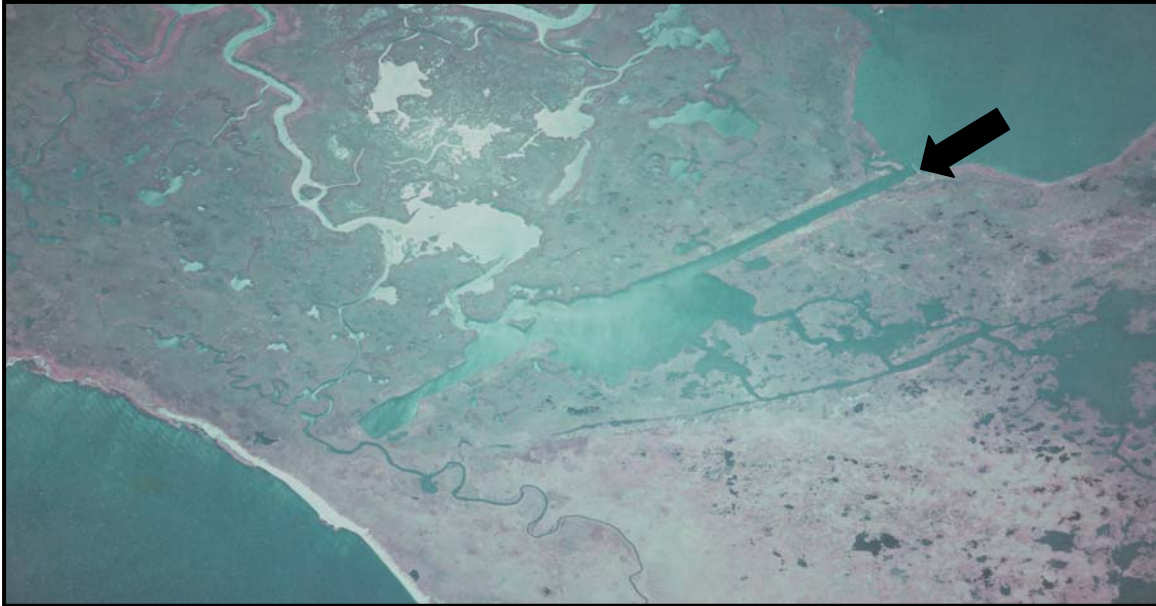
Interpreted information is from aerial imagery because no ground evaluation was performed at this site. This site is dissected by a large marsh pond with the spoil banks being effectively returned to marsh elevation on 90% of the non-pond segments of the canal. The plant species on the leveled spoil bank portions were unknown, but appeared similar to the surrounding marsh. Where elevated spoil remained the species composition was different and included shrubby species such as *Iva frutescens* and *Baccharis halimifolia*.

Figure 10. An infrared image of the backfilled canal at Hellhole Lake, noted by the arrow, that runs from Hellhole Lake at the top of the picture, dissects a large marsh pond, and terminates a few hundred m from the Gulf of Mexico. The image was taken in 2000.

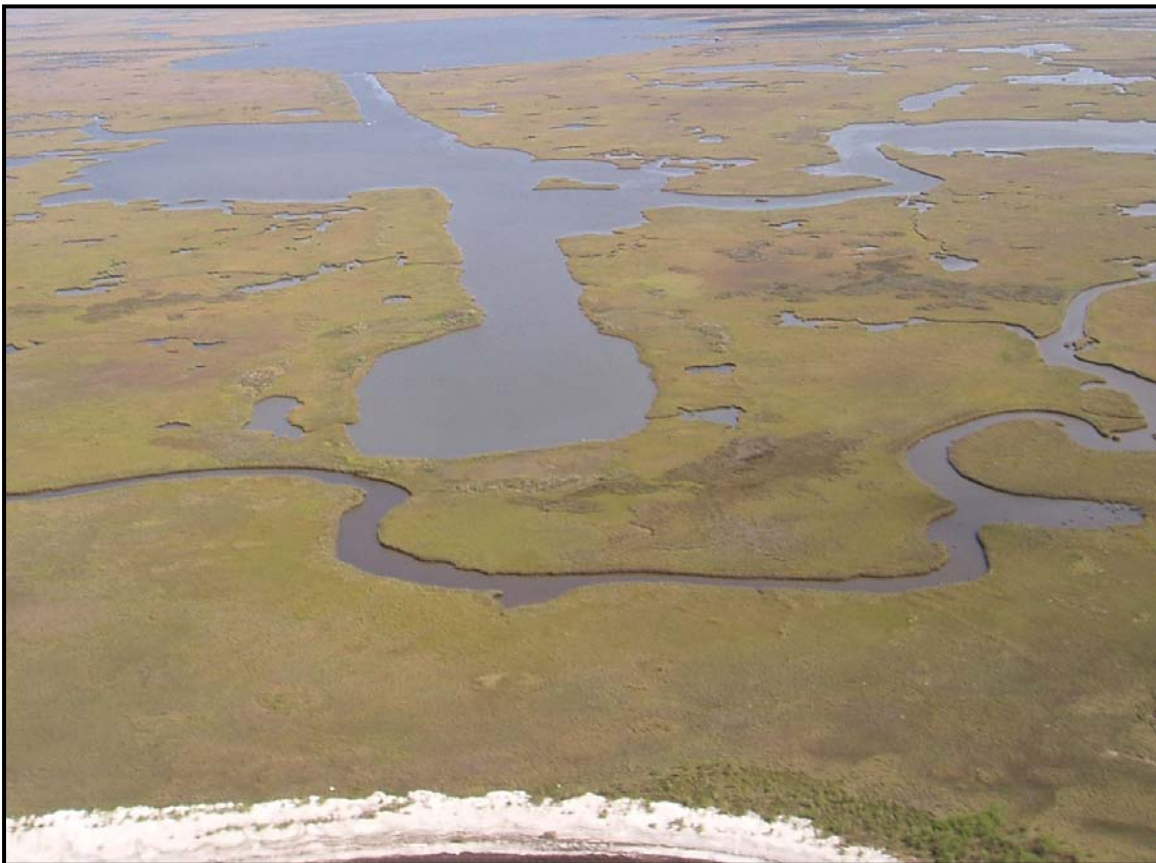
Figure 11. The Hellhole Lake backfilled site in October 2004.

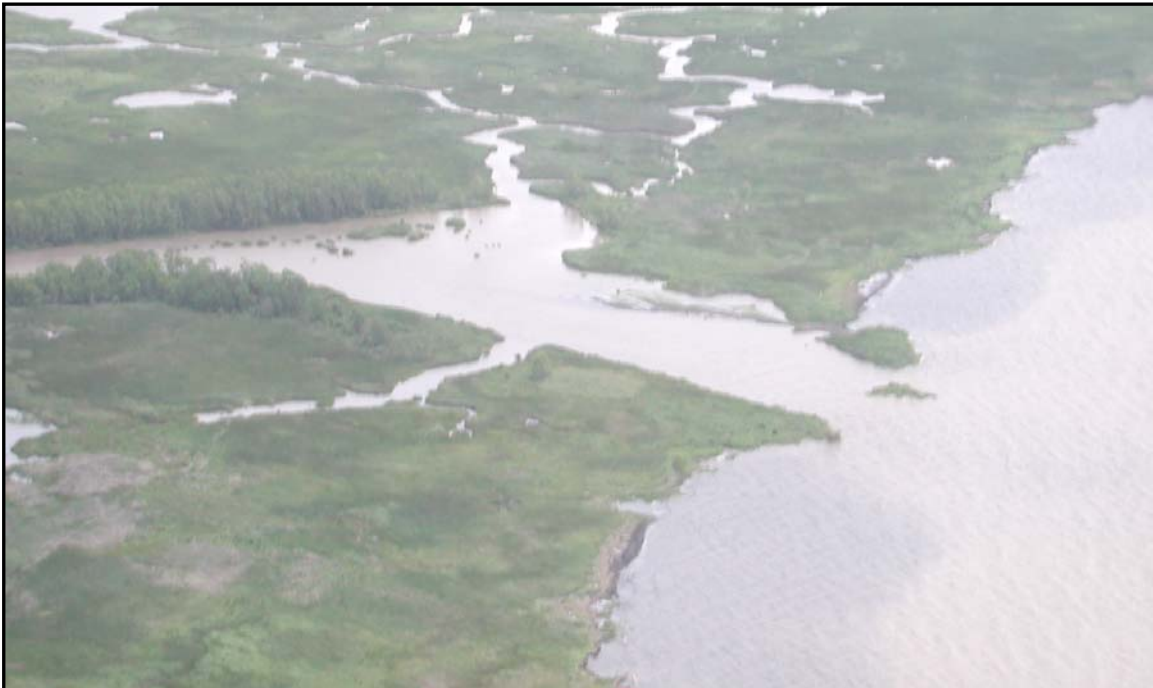
Figure 17. The Tigre Lagoon backfilled site in April 2004 with its newly established connection to the Gulf of Mexico.

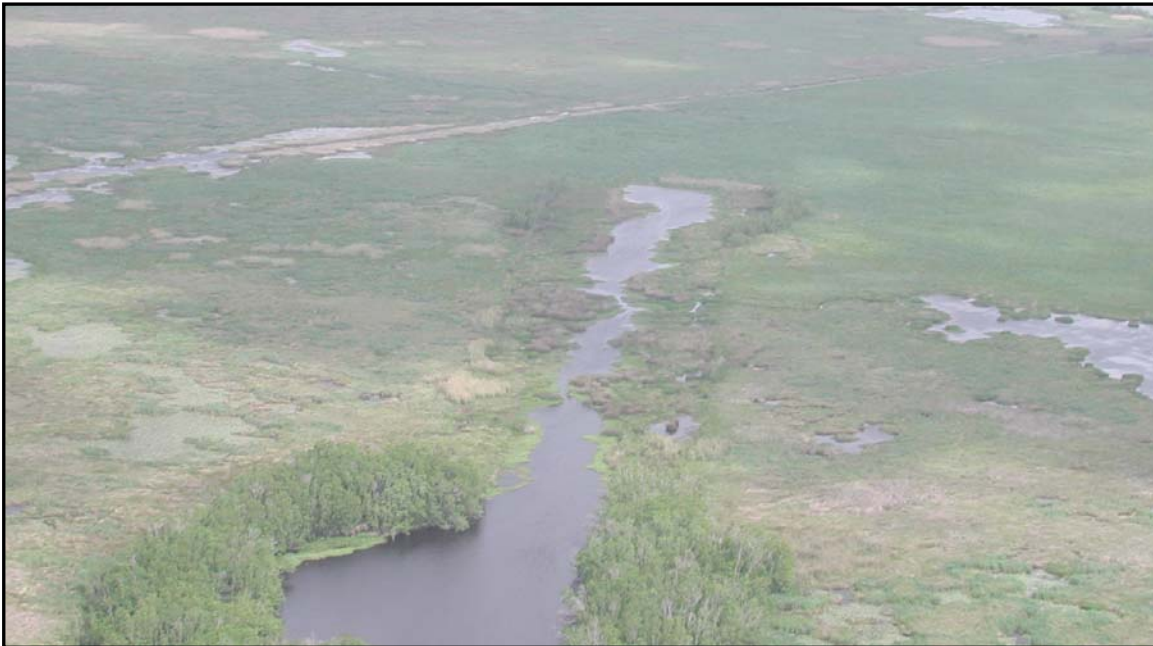
A normal ground inspection was not performed at this site because of adverse field conditions. Emergent vegetation has grown out over portions of the canal, making travel by boat impossible, and water levels in the marsh made passage by foot difficult. Visual inspection revealed that the spoil banks were effectively returned to marsh elevation over nearly 90% of their area. The only elevated spoil remaining was along the outer edge of the spoil banks surrounding the turning basin. Overall the site was backfilled well. The canal has become narrower as emergent vegetation encroaches from the sides. Floating and submerged vegetation was also present in the canal.

Figure 21. The Grand L'ac Huit backfilled seen in April 2004.

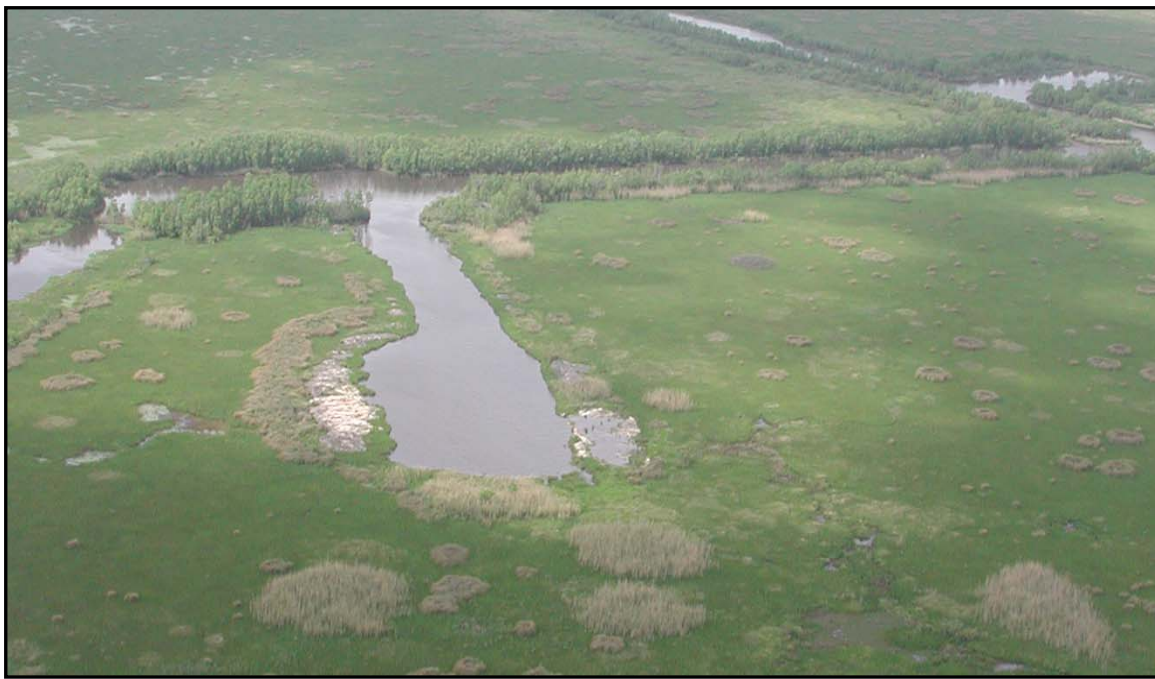
No site evaluation was conducted at this canal, all data collected was from aerial observations. The spoil banks appeared effectively leveled with no elevated spoil remaining. The vegetation on the former spoil bank areas looks similar to that of the surrounding marsh, and includes a few patches of Roseau Cane (*Phragmites australis*). There are small ponds in the former spoil bank area where spoil was removed to deeply on either side of the turning basin.

Figure 25. The Mallard Bay West backfilled site in April 2004.

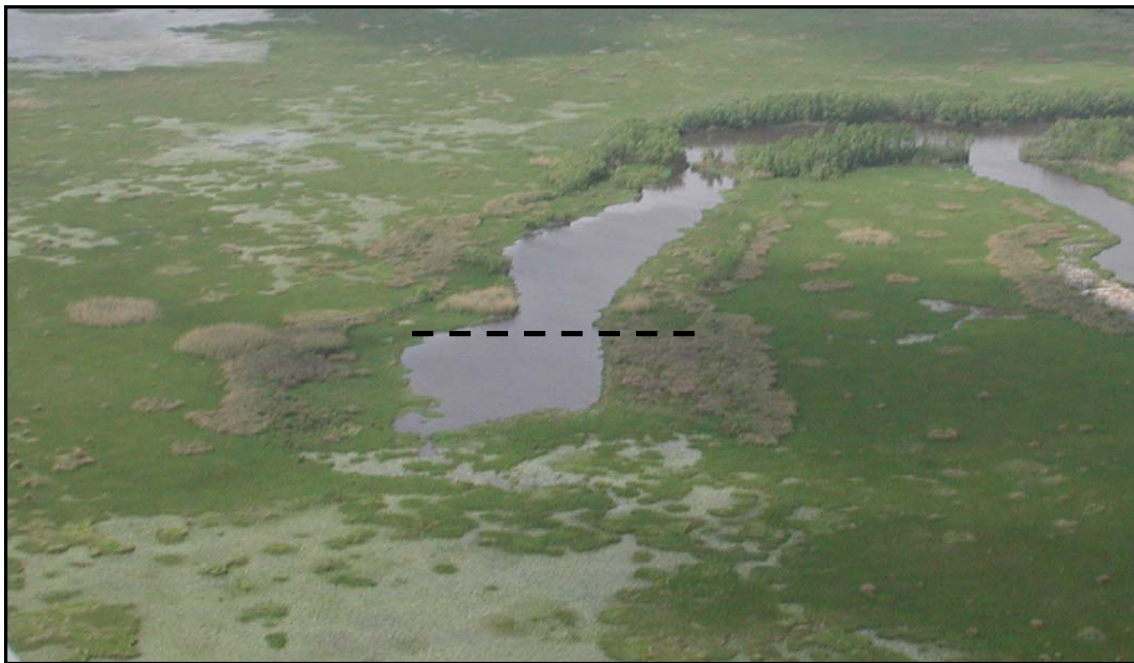
No site evaluation was conducted at this canal, and all data collected was from aerial observations. This canal was actually dredged and backfilled on two separate occasions. The data above is from the canal as it was originally dredged. The dashed line in Figure 27 indicates the separation between the original canal boundary and the extension of the canal after it was re-dredged. The spoil banks appeared effectively leveled with only a few spots of elevated spoil remaining that harbored spoil vegetation. The vegetation on the former spoil bank areas looks similar to that of the surrounding marsh, and includes a few patches of Roseau Cane (*Phragmites australis*). There are small ponds in the former spoil bank area where spoil was removed to deeply on either side of the turning basin.

Figure 27. The Mallard Bay East backfilled canal in April 2004. The dashed line indicates the newer canal portion, which was dredged after the original backfilling, and the entire canal was then backfilled once more.

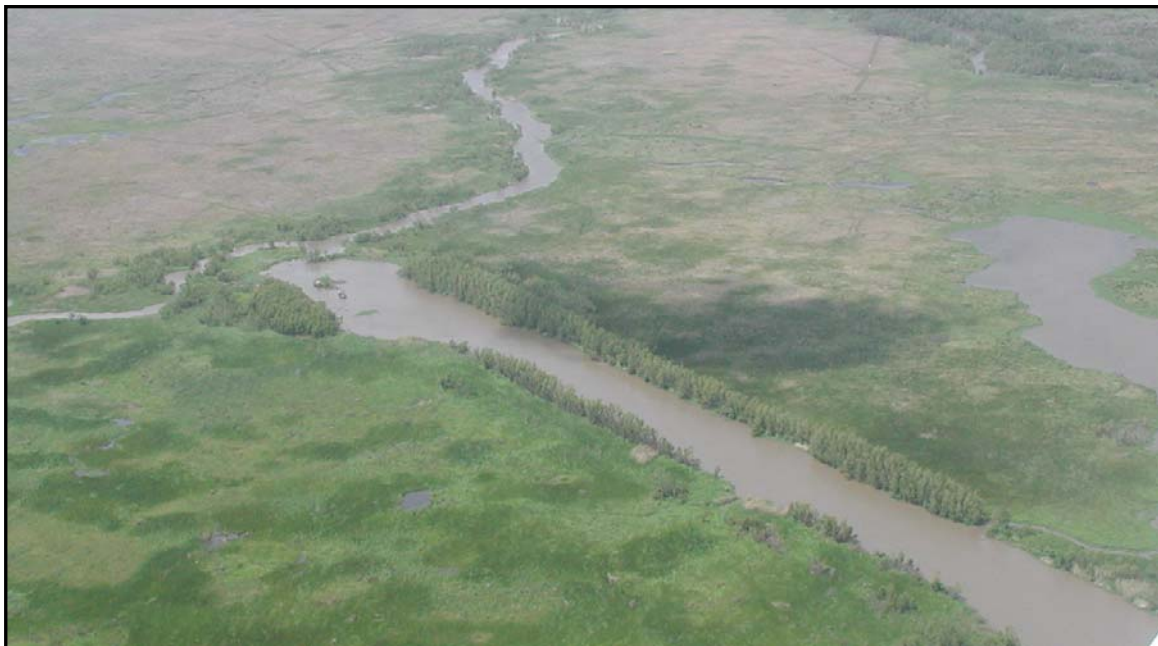
There was active drilling at this site, and the canal may have been re-dredged to allow drilling equipment to be brought in. The average canal depth was 1.6 m, but depths in the middle of the canal approached 3 m. Aerial photography from 1990 show the spoil banks to be mostly open water with a few trees not touched by backfilling. Photographs from 2000 and 2004 show drilling platforms in the canal and the open water portions of the spoil bank have become trees or marsh. This evidence suggests that material may have been moved from the bottom of the canal and placed along its sides, decreasing water depth on the former spoil banks, and allowing emergent vegetation to grow on the newly elevated areas. The data collected at this canal was not used in any of the data analysis because of the active drilling and possible re-dredging.

Figure 33. The Lake Point Bayou backfilled site in April 2004.

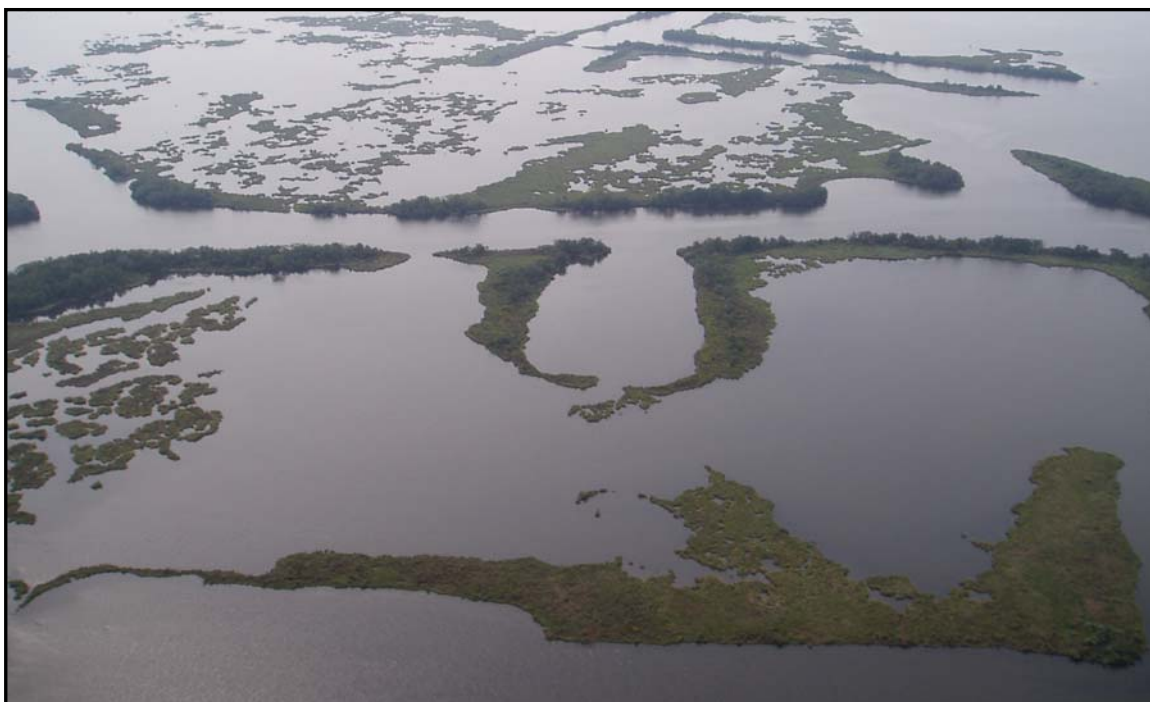
The original evaluation of this canal in 1984 noted that the site had no appearance of ever being backfilled. The site occurred in the Lafitte Oil Field, an area highly impacted by oil and gas activities, with nearly all marsh between canals being turned to open water. The only emergent vegetation immediately surrounding this canal was on spoil banks.

Figure 43. The Lafitte backfilled site in October 2004.

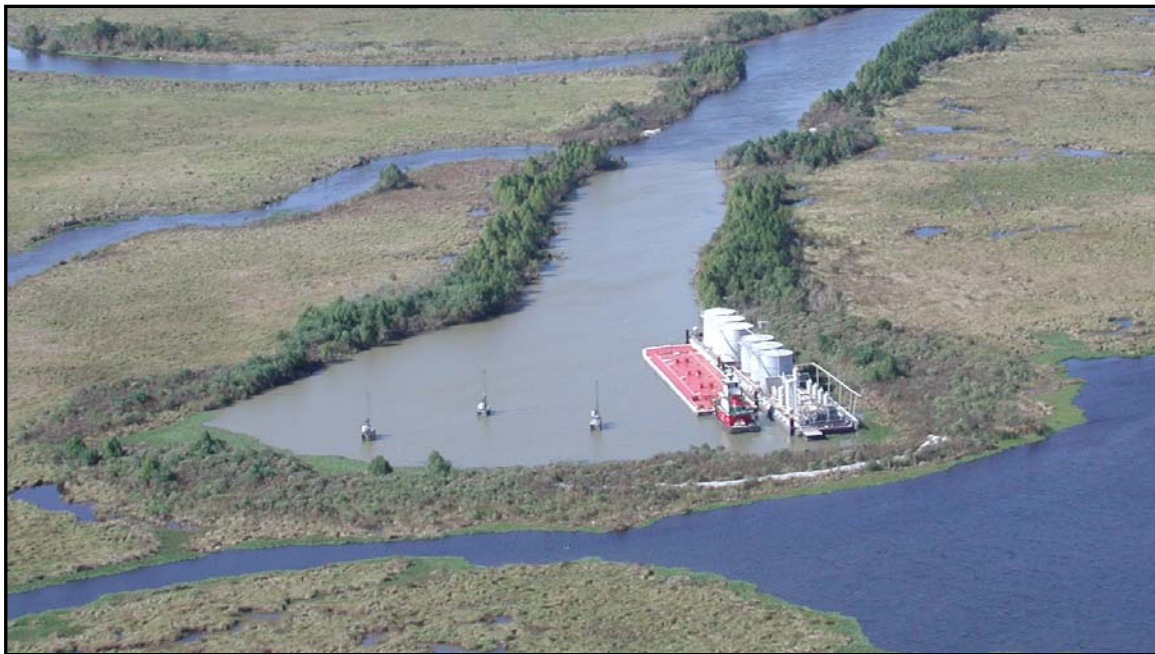
Figure 49. The Lake DeCade backfilled site in November 2003 after it was reopened for drilling.

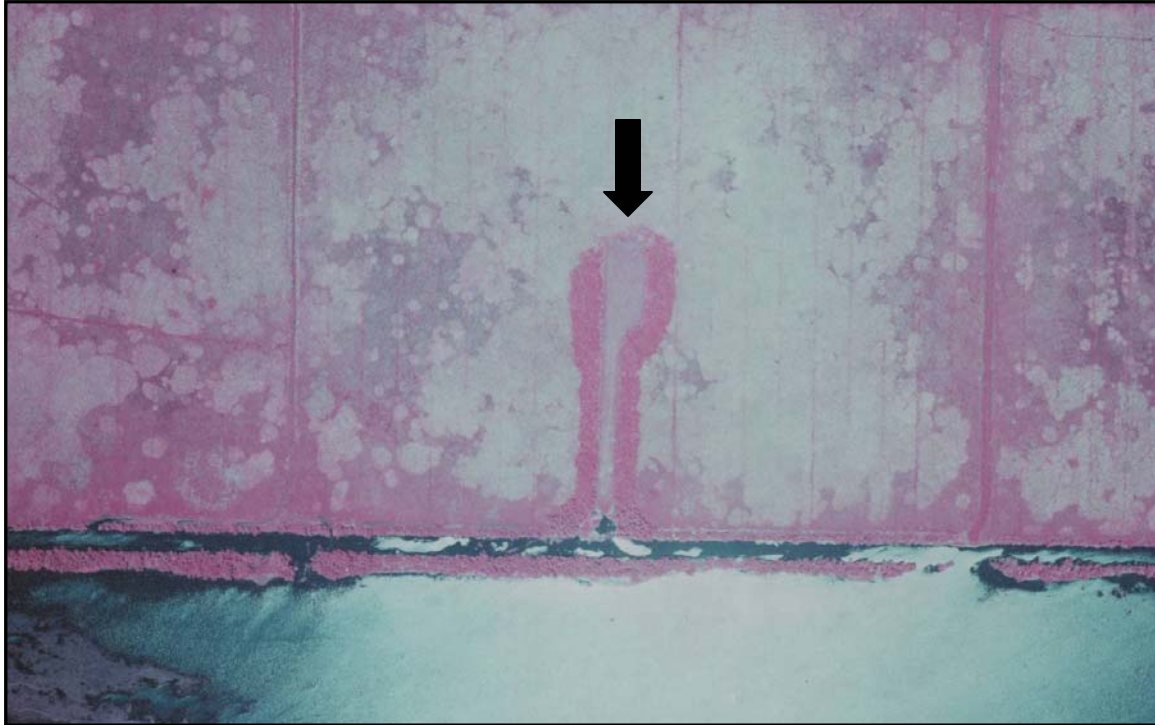
No ground evaluation was conducted at this site because of restricted access, and private hunting leases. From the air, this site appears to never have been backfilled. Trees line the entire spoil bank, except for at the extreme northern end of the turning basin. The canal is located in a failed agricultural area that has since returned to marsh, but the original agricultural drainage canals are visible.

Figure 64. An infrared image of the Delta Farms backfilled canal, noted by the arrow, taken in 2000. The canal is filled with floating vegetation such as Water Hyacinth (*Eichhornia crassipes*).

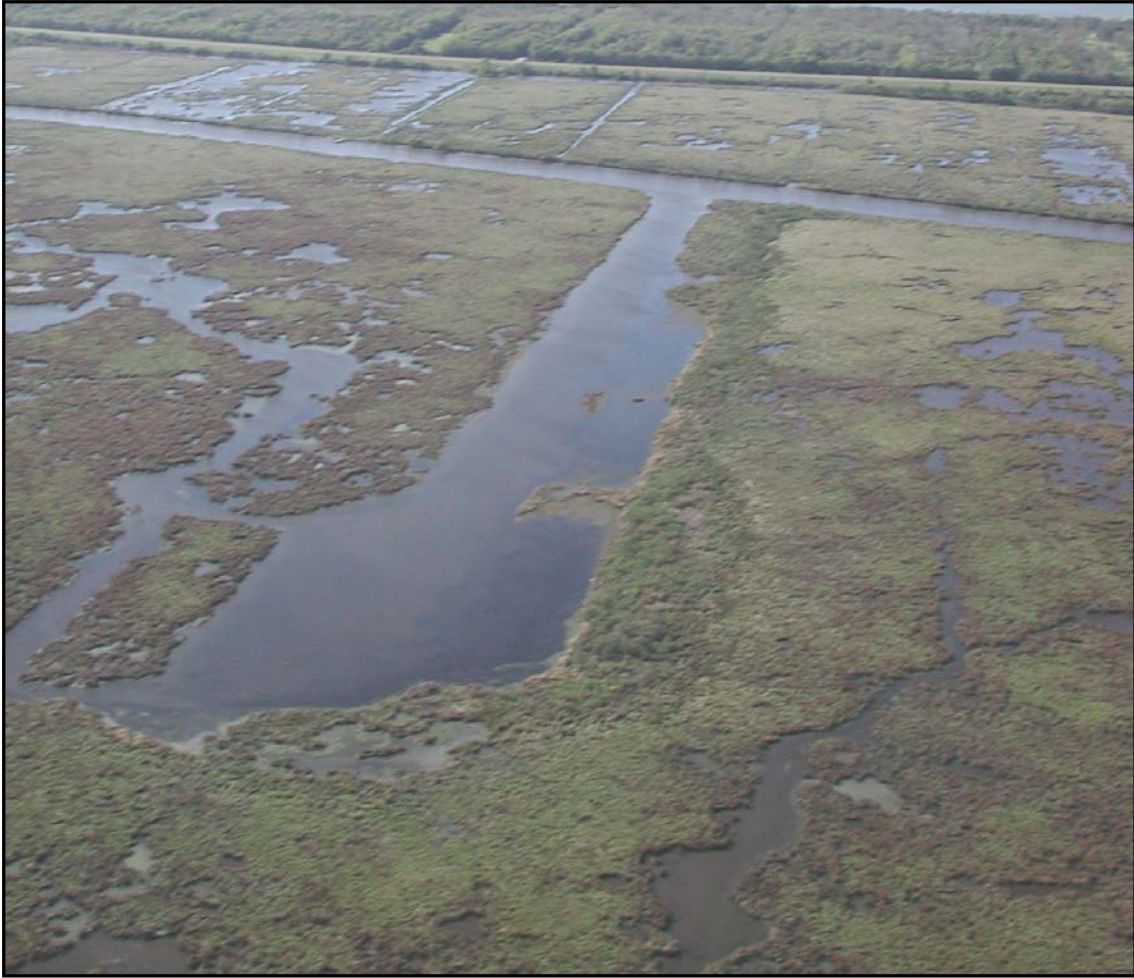
Spoil Banks. The spoil banks were leveled to marsh elevation along 50% of their area, and remained elevated spoil along 25% of their area. Twenty-five percent of the spoil area was dug deeper than marsh elevation and remained as shallow water less than 30 cm. The elevated portion of the spoil bank was entirely on the northern spoil bank, and was populated by spoil vegetation including Goldenrod (*Solidago sp.*), and Marsh Elder (*Iva frutescens*). The portions of the spoil bank at marsh elevation were populated by Marshhay Cordgrass (*Spartina patens*), Salt Marsh Loosestrife (*Lythrum lineare*), Common Three-square (*Schoenoplectus americanus*), Smartweed (*Polygonum sp.*), and Mock Bishopweed (*Ptilimnium capillaceum*).

Figure 74. The Point à la Hache backfilled site in November 2003.
