Restoration success of backfilling canals in coastal Louisiana marshes

RESTORATION SUCCESS OF BACKFILLING
CANALS IN COASTAL LOUISIANA MARSHES

A Thesis

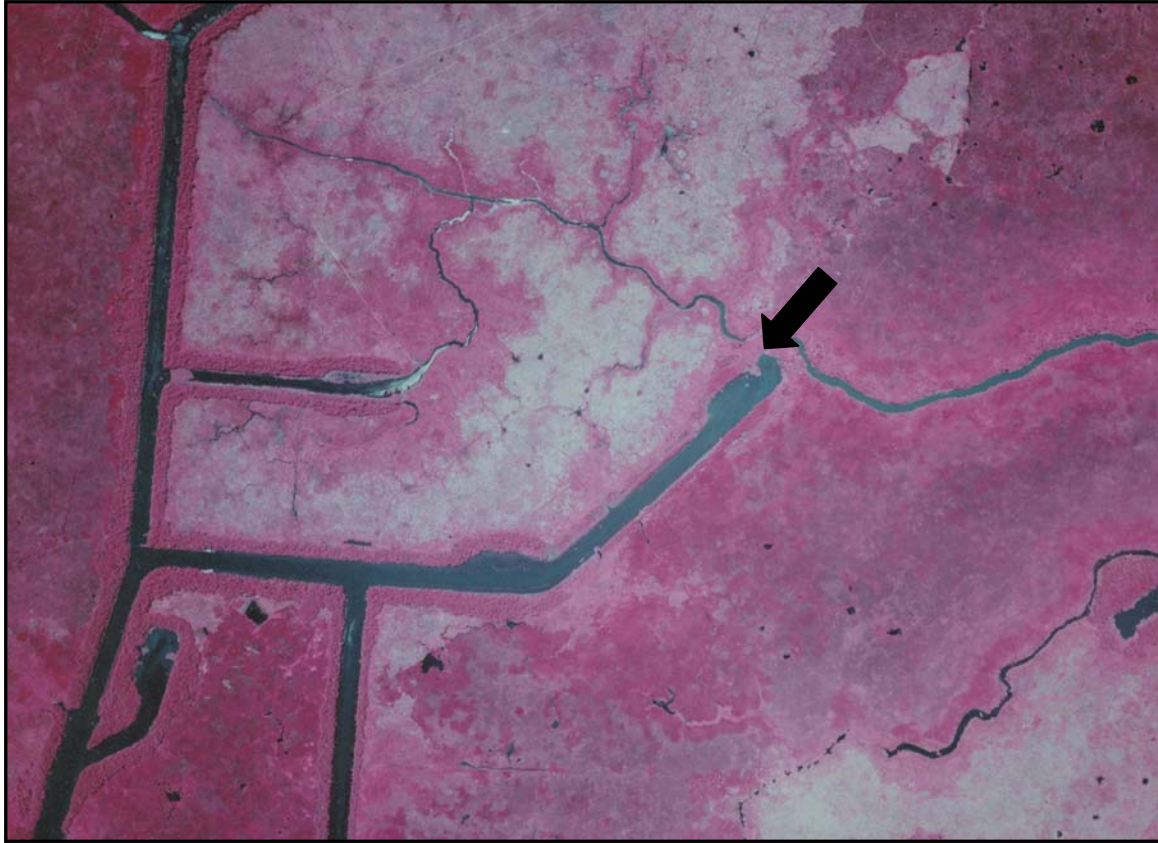
There was active drilling at this site, and the canal may have been re-dredged to allow drilling equipment to be brought in. The average canal depth was 1.6 m, but depths in the middle of the canal approached 3 m. Aerial photography from 1990 show the spoil banks to be mostly open water with a few trees not touched by backfilling. Photographs from 2000 and 2004 show drilling platforms in the canal and the open water portions of the spoil bank have become trees or marsh. This evidence suggests that material may have been moved from the bottom of the canal and placed along its sides, decreasing water depth on the former spoil banks, and allowing emergent vegetation to grow on the newly elevated areas. The data collected at this canal was not used in any of the data analysis because of the active drilling and possible re-dredging.

Figure 32. An infrared image of the Lake Point Bayou backfilled canal, noted by the arrow, taken in 2000.

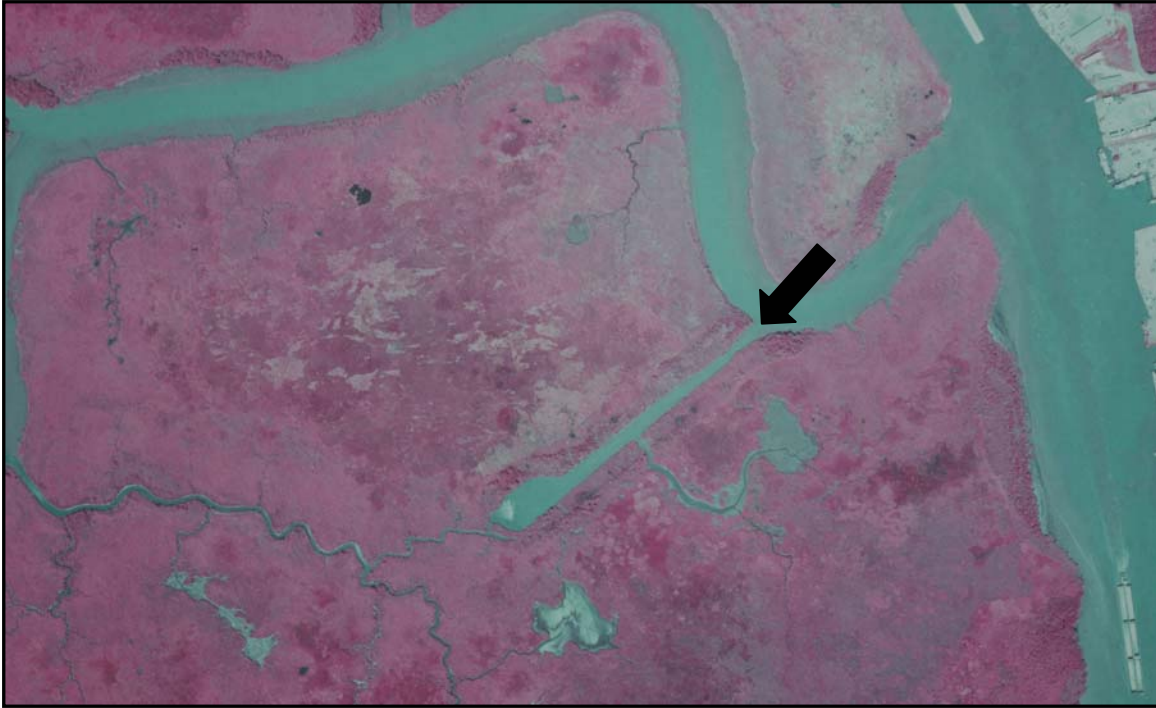
Spoil Banks. The spoil banks had several areas that were left higher than marsh elevation and supported spoil vegetation such as Chinese Tallow Trees (*Sapium sebiferum*), Marsh Elder (*Iva frutescens*), Brambles (*Rubus sp.*), and Goldenrod (*Solidago sp.*). The portions of the spoil bank that were at marsh elevation were predominately covered by Roseau cane (*Phragmites australis*), with Sawgrass (*Cladium jamaicense*), Marshhay Cordgrass (*Spartina patens*), Mock Bishopweed (*Ptilimnium capillaceum*), Marsh Morning Glory (*Ipomoea sagittata*), and Bull-tongue (*Sagittaria lancifolia*) also present.

Figure 34. An infrared image of the Vermilion River backfilled canal, noted by the arrow, taken in 2000.

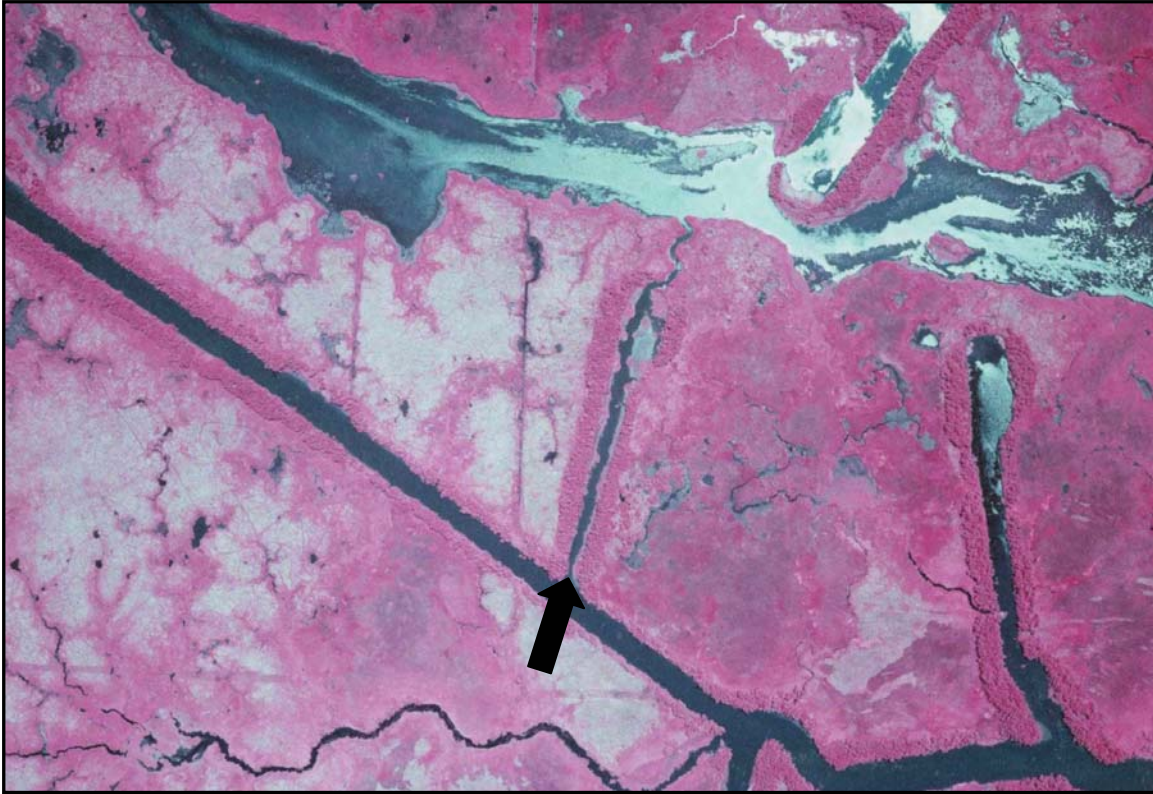
Spoil Banks. The spoil banks remained elevated above marsh level and supported trees and other spoil vegetation. The spoil banks were dominated by Black Willow (*Salix nigra*), with Chinese Tallow (*Sapium sebiferum*) and Wax Myrtle (*Myrica cerifera*) present. The edges of the spoil bank contained plant species similar to the marsh including: Elderberry (*Sambucus Canadensis*), Bull-tongue (*Sagittaria lancifolia*), Elephant Ear (*Colocasia antiquorum*), Common Three-square (*Schoenoplectus americanus*), Rice Cutgrass (*Leersia oryzoides*), Alligatorweed (*Alternanthera philoxeroides*), Smartweed (*Polygonum* sp.), Deer Pea (*Vigna luteola*).

Figure 36. An infrared image of the Bayou Long backfilled canal, noted by the arrow, taken in 2000.

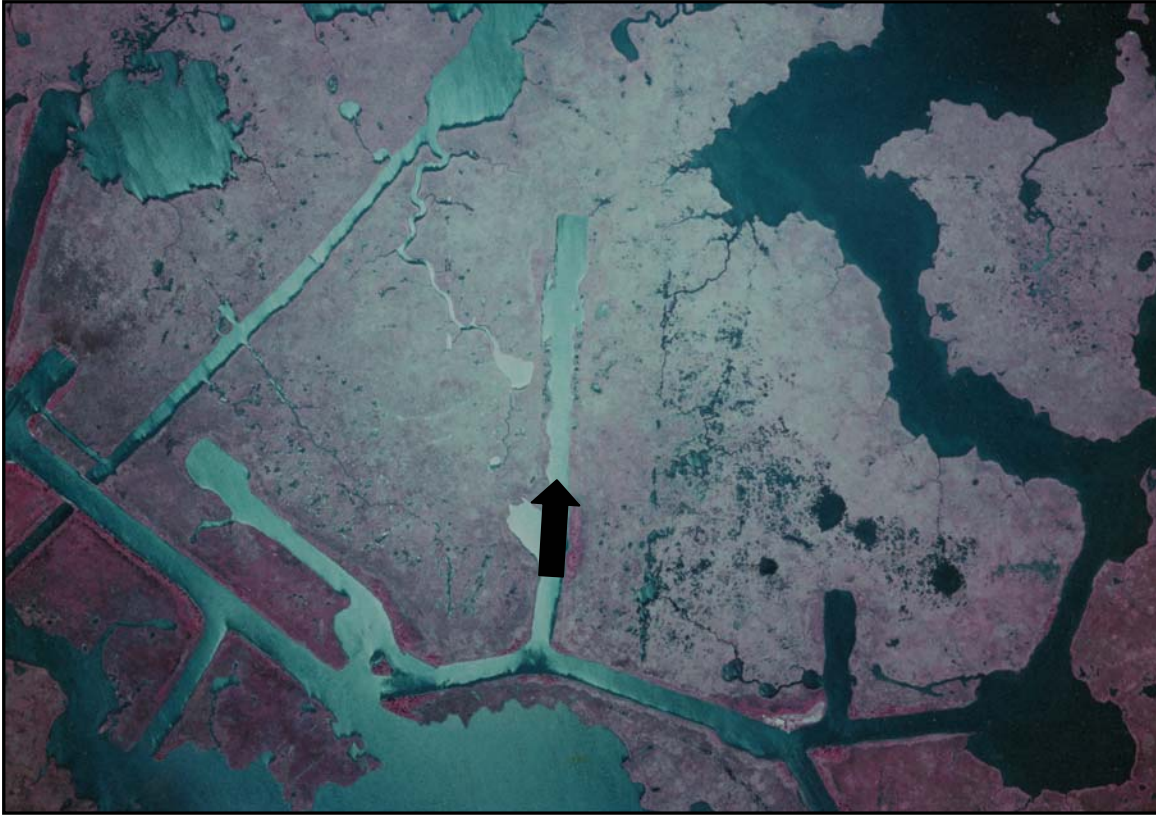
Spoil Banks. The spoil banks were effectively leveled to, or below, marsh elevation over the entire length of the canal. There were many places along the spoil bank where too much material was removed leaving shallow water ponds. Where the spoil was returned to marsh elevation, species composition was similar to the surrounding marsh and included: Smooth Cordgrass (*Spartina alterniflora*), Marshhay Cordgrass (*Spartina patens*), Saltgrass (*Distichlis spicata*), Black Needlerush (*Juncus roemarianus*), Salt Marsh Loosestrife (*Lythrum lineare*), Marsh Morning Glory (*Ipomoea sagittata*), Marsh Elder (*Iva frutescens*), and one large patch of Roseau Cane (*Phragmites australis*).

Figure 38. An infrared image of the Four Isle backfilled canal, noted by the arrow, taken in 2000.

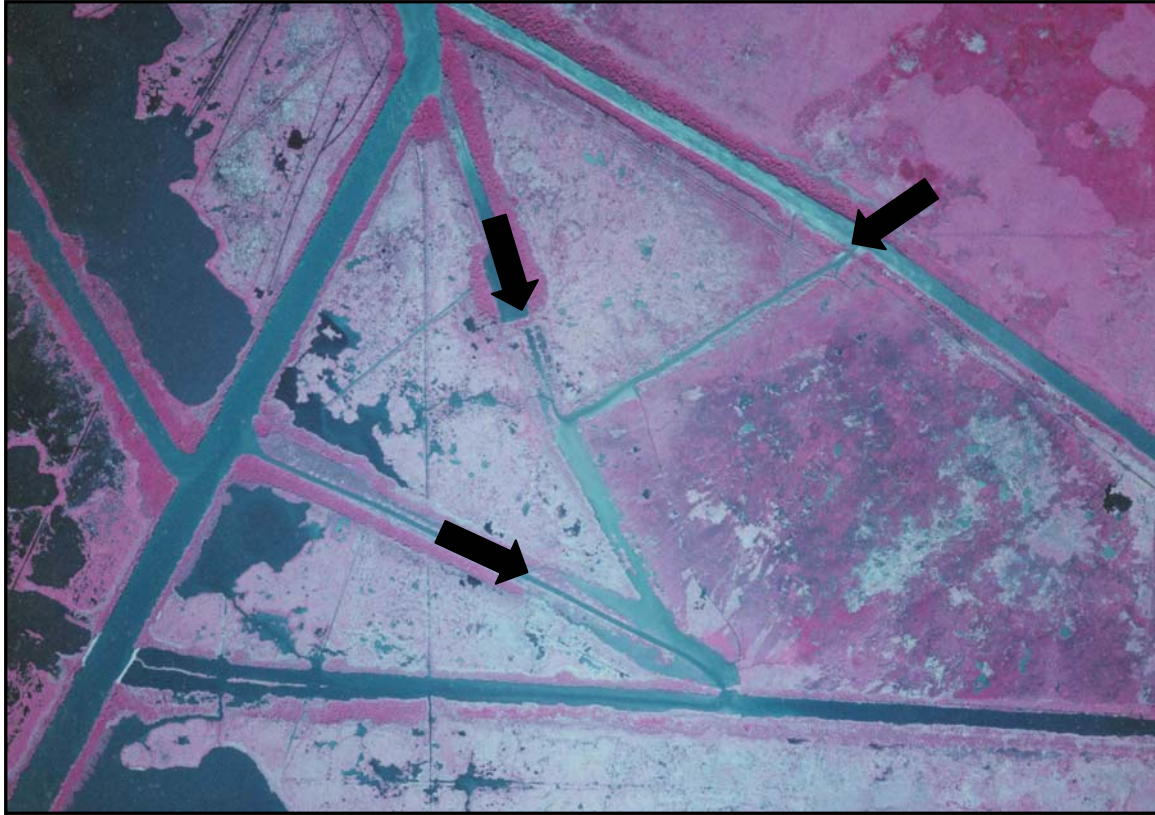
Spoil Banks. The spoil banks were effectively leveled, leaving 100% of the spoil banks at or below marsh elevation. The vegetation immediately next to the open water portions of the canal was mostly Roseau Cane (*Phragmites australis*), and Sedges (*Cyperus* sp.); while behind that Marshhay Cordgrass (*Spartina patens*) was the dominate species with Joint Paspalum (*Paspalum distichum*), and Smartweed (*Polygonum* sp.) also present.

Figure 40. An infrared image of the Pecan Island West backfilled canal taken in 2000. Note the three separate backfilled canals identified by the arrows.

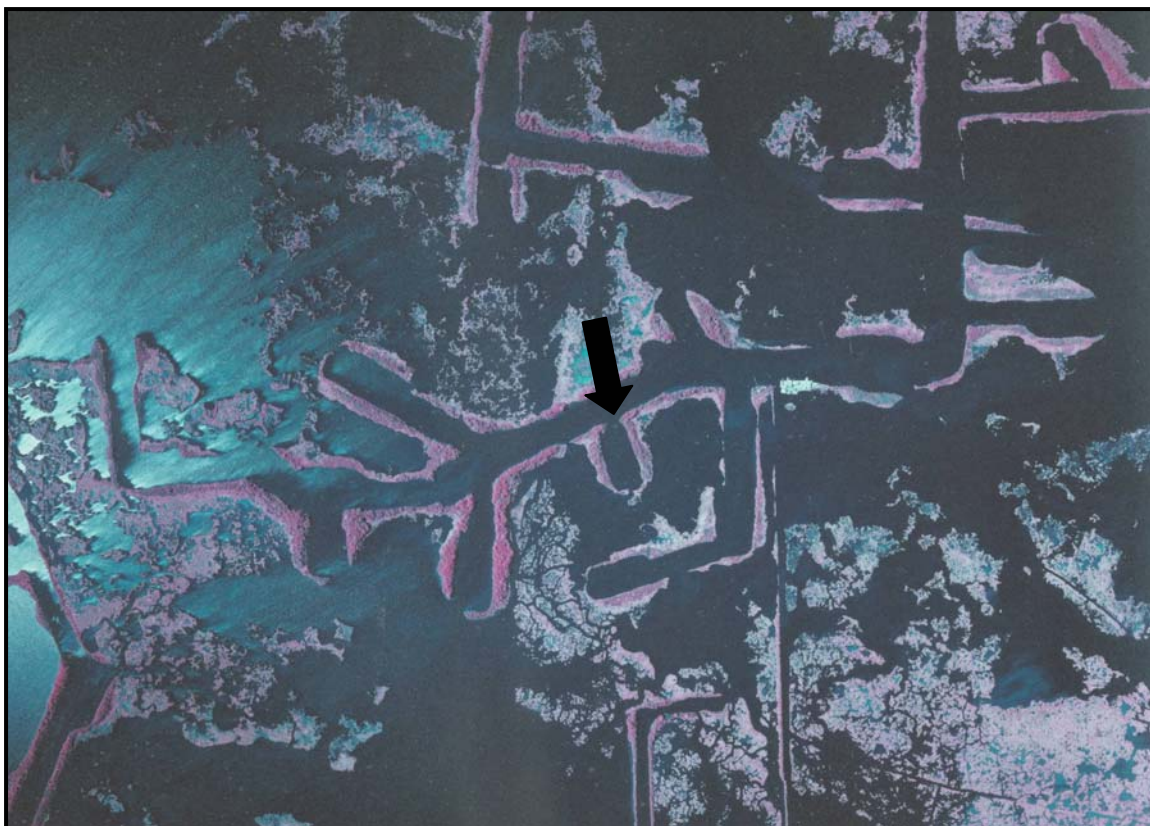
The original evaluation of this canal in 1984 noted that the site had no appearance of ever being backfilled. The site occurred in the Lafitte Oil Field, an area highly impacted by oil and gas activities, with nearly all marsh between canals being turned to open water. The only emergent vegetation immediately surrounding this canal was on spoil banks.

Figure 42. An infrared image of the Lafitte backfilled canal, noted by the arrow, taken in 2000.

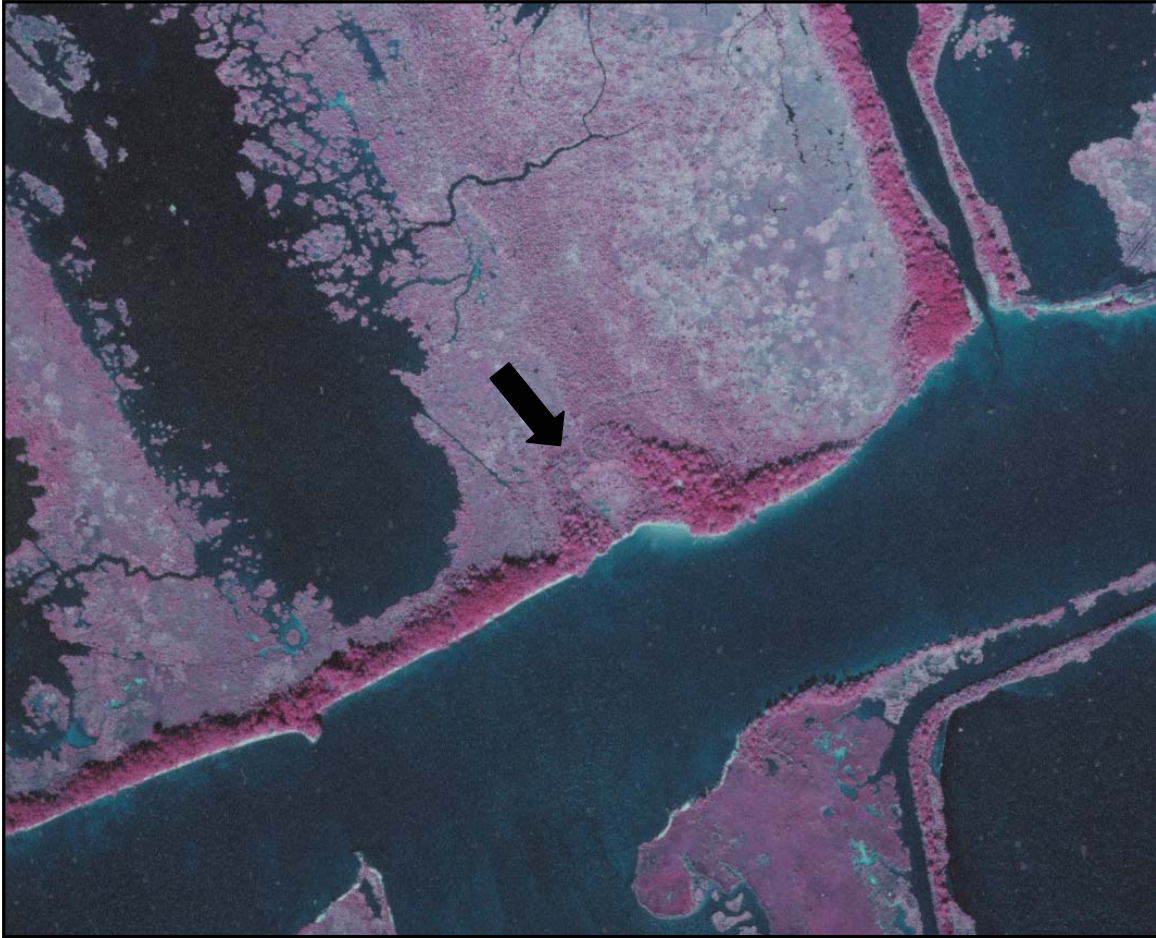
Spoil Banks. The spoil banks remained elevated higher than marsh elevation in a nearly complete ridge around the canal. The spoil bank on the north side of the canal was higher than the south spoil; near the Barataria Waterway, the spoil was over 4 m high. The plant species on the spoil surrounding the canal included: Groundselbush (*Baccharis halimifolia*), Goldenrod (*Solidago* sp.), Marshhay Cordgrass (*Spartina patens*), Marsh Elder (*Iva frutescens*), Smartweed (*Polygonum* sp.), and Pennywort (*Hydrocotyle umbellata*).

Figure 44. An infrared image of the Dupree Cut backfilled canal, noted by the arrow, taken in 2000.

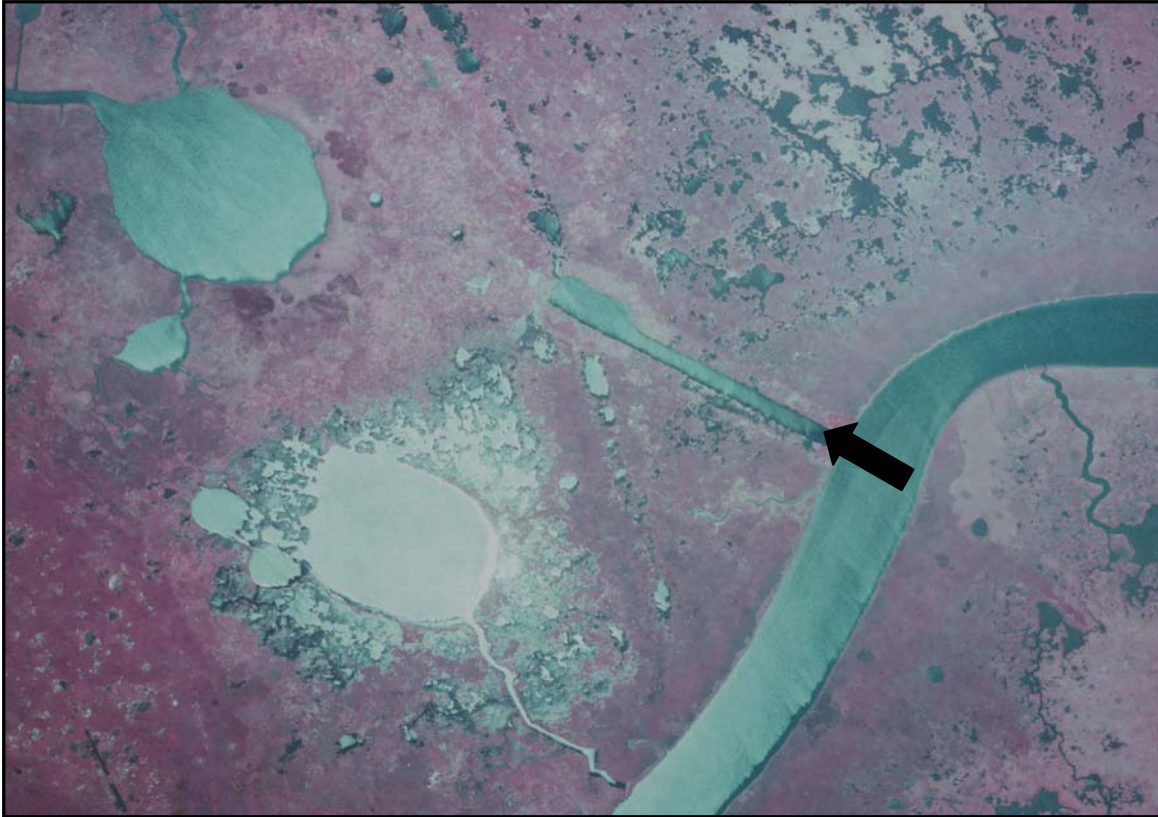
Spoil Banks. The spoil banks were effectively leveled to marsh elevation over 90% of their area, with elevated spoil remaining along the sides of the plug. A slightly elevated portion of spoil remained around the turning basin, and was colonized by Marsh Elder (*Iva frutescens*), and Sea Ox-eye (*Borrchia frutescens*). The portions of the spoil bank that were at marsh elevation contained 75% Saltgrass (*Distichlis spicata*), with Smooth Cordgrass (*Spartina alterniflora*), Salt Marsh Bulrush (*Schoenoplectus robustus*), and Marsh Morning Glory (*Ipomoea sagittata*).

Figure 46. An infrared image of the Buckskin Bayou backfilled canal, noted by the arrow, taken in 2000.

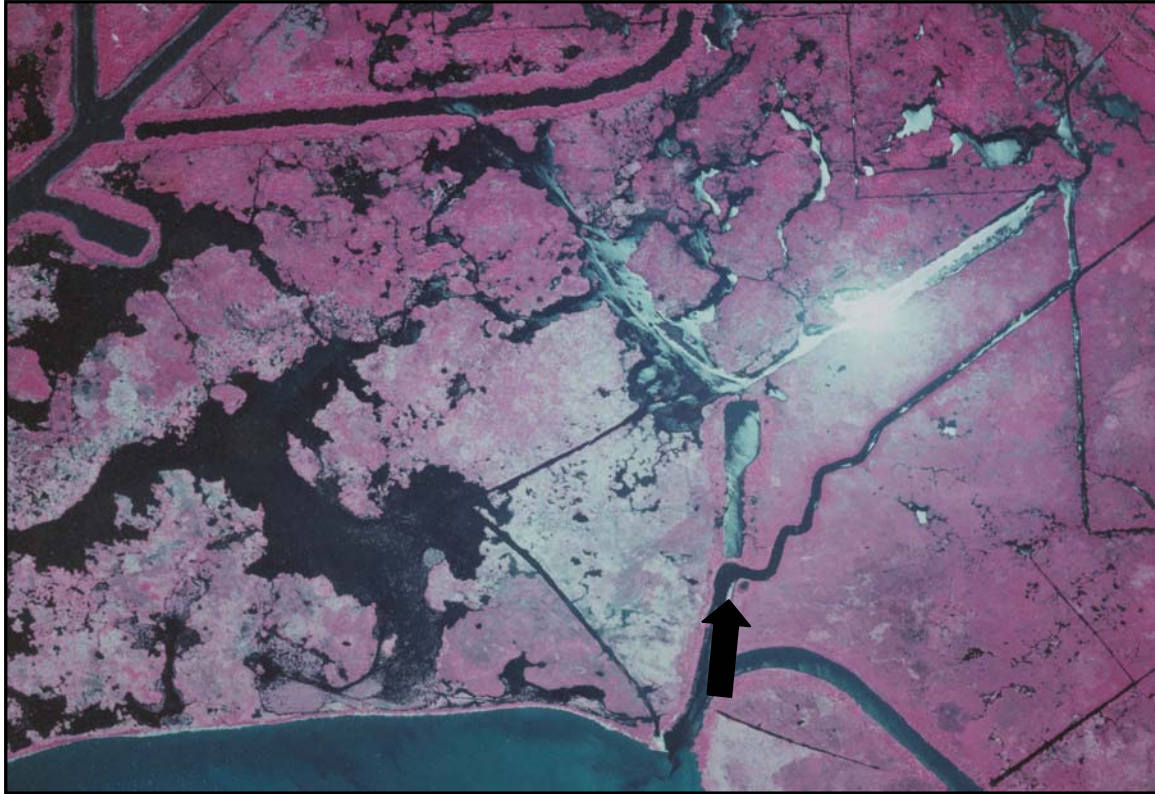
The backfilled canal at Lake DeCade had its plug removed and was swept out to allow for barges to bring in the drilling equipment which is now present in the canal. There was no sampling done at this site because there was active drilling in the canal.

Figure 48. An infrared image of the Lake DeCade backfilled canal, noted by the arrow, taken in 2000.

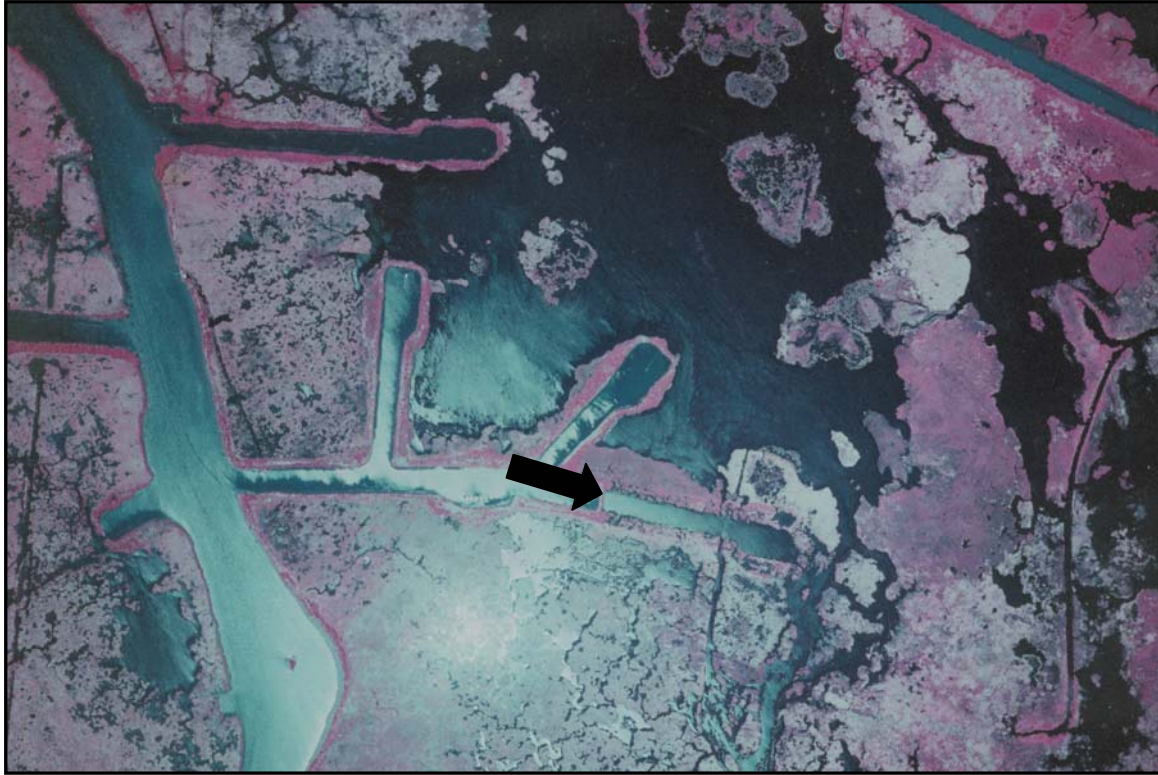
Spoil Banks. The spoil banks were effectively leveled to marsh elevation over 83% of their area. The plant species present in the portions of the spoil bank that were at marsh elevation included: Groundsel Bush (*Baccharis halimifolia*), Bull-tongue (*Sagittaria lancifolia*), Spikerush (*Eleocharis* sp.), Smartweed (*Polygonum* sp.), Marshhay Cordgrass (*Spartina patens*), and Alligatorweed (*Alternanthera philoxeroides*).

Figure 50. An infrared image of the Falgout Canal backfilled canal, noted by the arrow, taken in 2000.

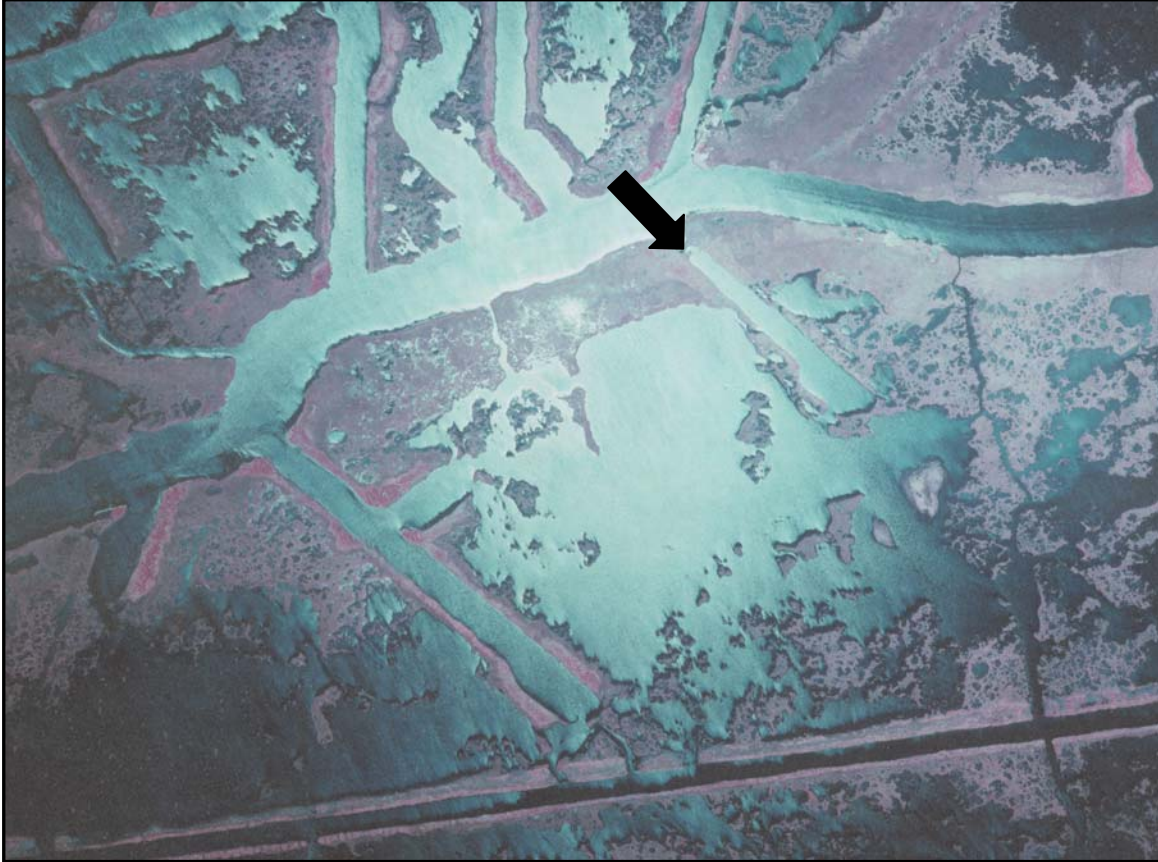
Spoil Banks. The spoil banks were returned to marsh elevation over approximately 50% of their area. The elevated portions of the spoil bank contained Marsh Elder (*Iva frutescens*), Sea Ox-eye (*Borrichia frutescens*), and Smooth Cordgrass (*Spartina alterniflora*). The portions of the spoil bank that were at marsh elevation had a similar species composition as the surrounding marsh, and included: Marshhay Cordgrass (*Spartina patens*), Saltgrass (*Distichlis spicata*), and Smooth Cordgrass (*Spartina alterniflora*).

Figure 52. An infrared image of the Catfish Lake backfilled canal, noted by the arrow, taken in 2000.

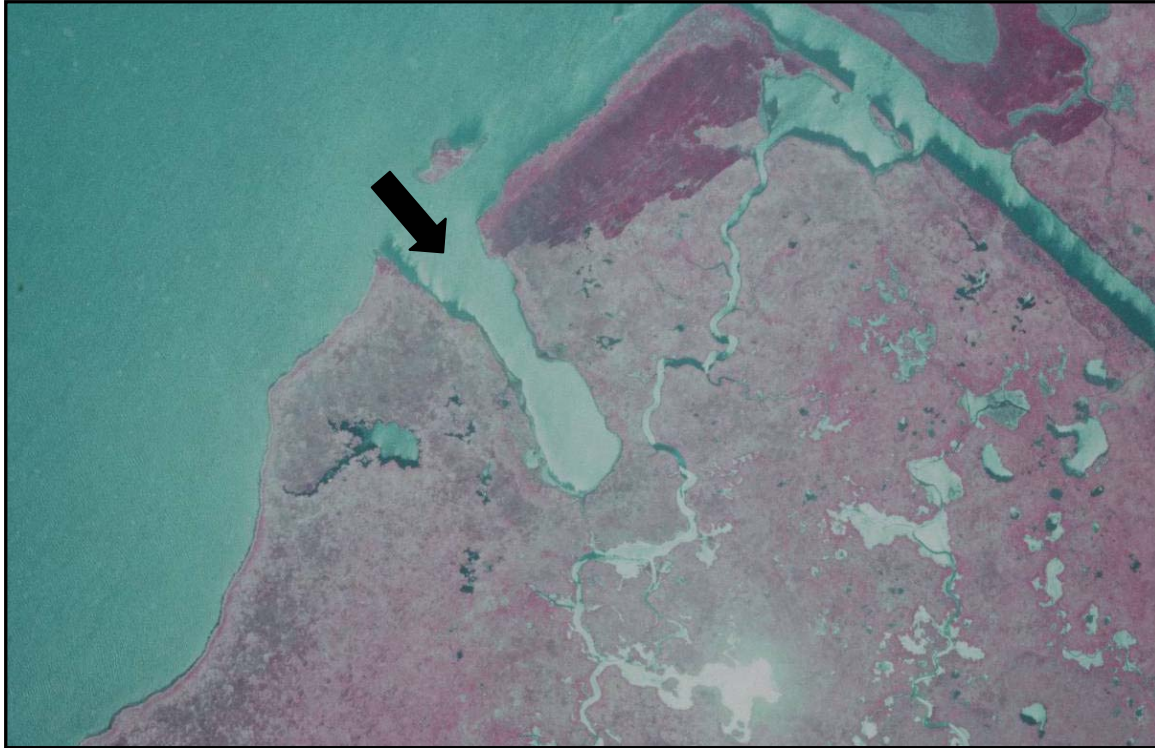
Spoil Banks. The spoil banks were completely leveled to marsh elevation over 95% of the spoil area. The spoil banks consisted of similar species as the marsh including: Common Three-square (*Schoenoplectus americanus*), Saltgrass (*Distichlis spicata*), Marshhay Cordgrass (*Spartina patens*), Salt Marsh Bulrush (*Schoenoplectus robustus*), Goldenrod (*Solidago* sp.), and Marsh Morning Glory (*Ipomoea sagittata*).

Figure 54. An infrared image of the Four League Bay backfilled canal, noted by the arrow, taken in 2000.

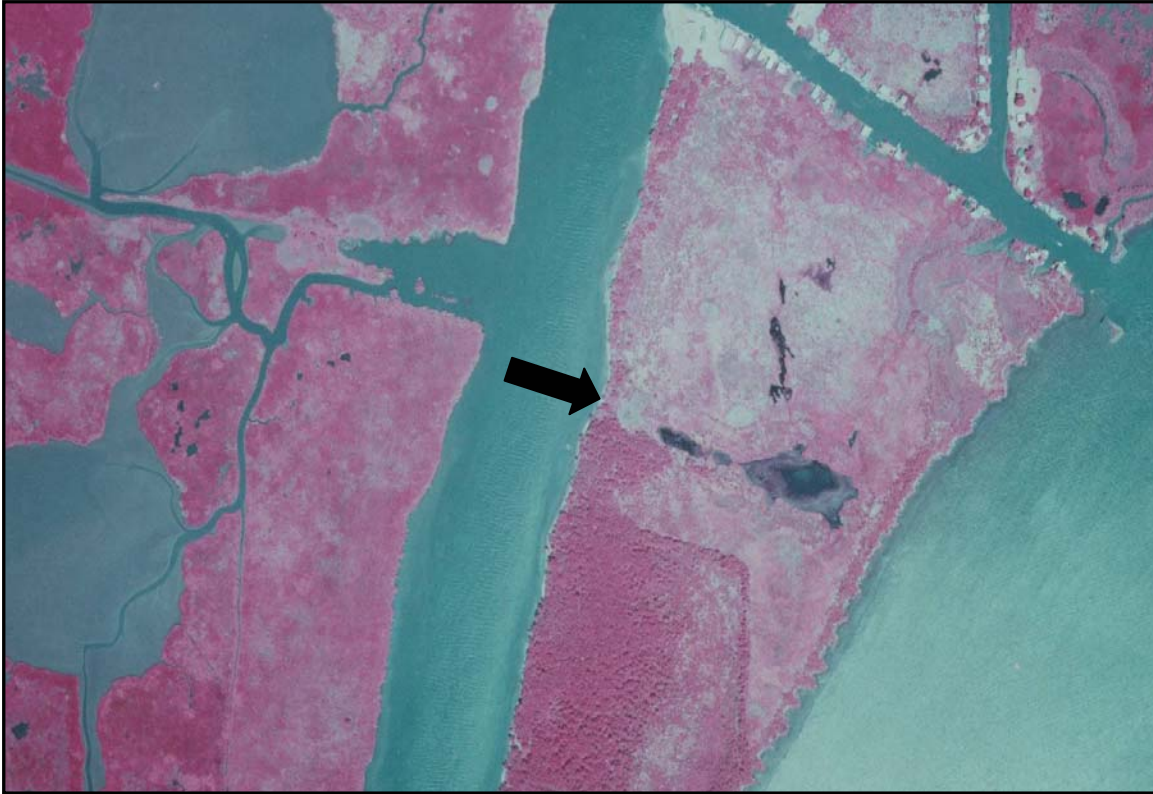
Spoil Banks. The spoil banks were leveled effectively to marsh elevation over 90% of their area. Elevated spoil remained in a few spots on the outer edges of the spoil bank and consisted of Marsh Elder (*Iva frutescens*), Goldenrod (*Solidago* sp.), Groundsel Bush (*Baccharis halimifolia*), Roseau Cane (*Phragmites australis*) and a few Chinese Tallow Trees (*Sapium sebiferum*). The portions of spoil bank that were at marsh elevation consisted of similar species as the marsh and included: Cattails (*Typha* sp.), Marshhay Cordgrass (*Spartina patens*), Common Three-square (*Schoenoplectus americanus*), Sedges (*Cyperus* sp.), and Joint Paspalum (*Paspalum distichum*).

Figure 56. An infrared image of the Oaks Canal backfilled site, noted by the arrow, taken in 2000

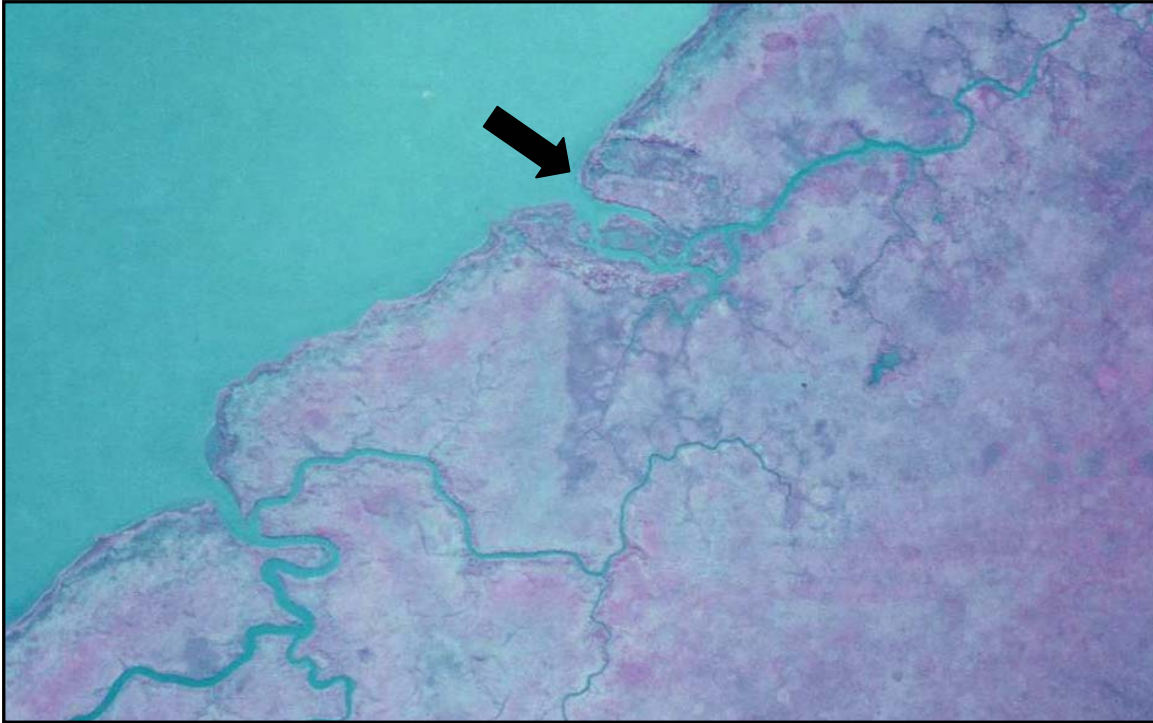
Spoil Banks. The spoil banks were leveled to marsh elevation over 75% of their area, with a narrow ridge of unfilled spoil on both the east and west sides of the canal. The vegetation on the ridges was different than the rest of the spoil bank and consisted of Groundselbush (*Baccharis halimifolia*), Marshhay Cordgrass (*Spartina patens*), and Sea Ox-eye (*Borrchia frutescens*). The portions of spoil bank that were at marsh elevation consisted of Smooth Cordgrass (*Spartina alterniflora*), Saltgrass (*Distichlis spicata*), Salt Marsh Bulrush (*Schoenoplectus robustus*), and Salt Marsh Aster (*Aster* sp.)

Figure 58. An infrared image of the Lower Mud Lake backfilled canal, noted by the arrow, taken in 2000

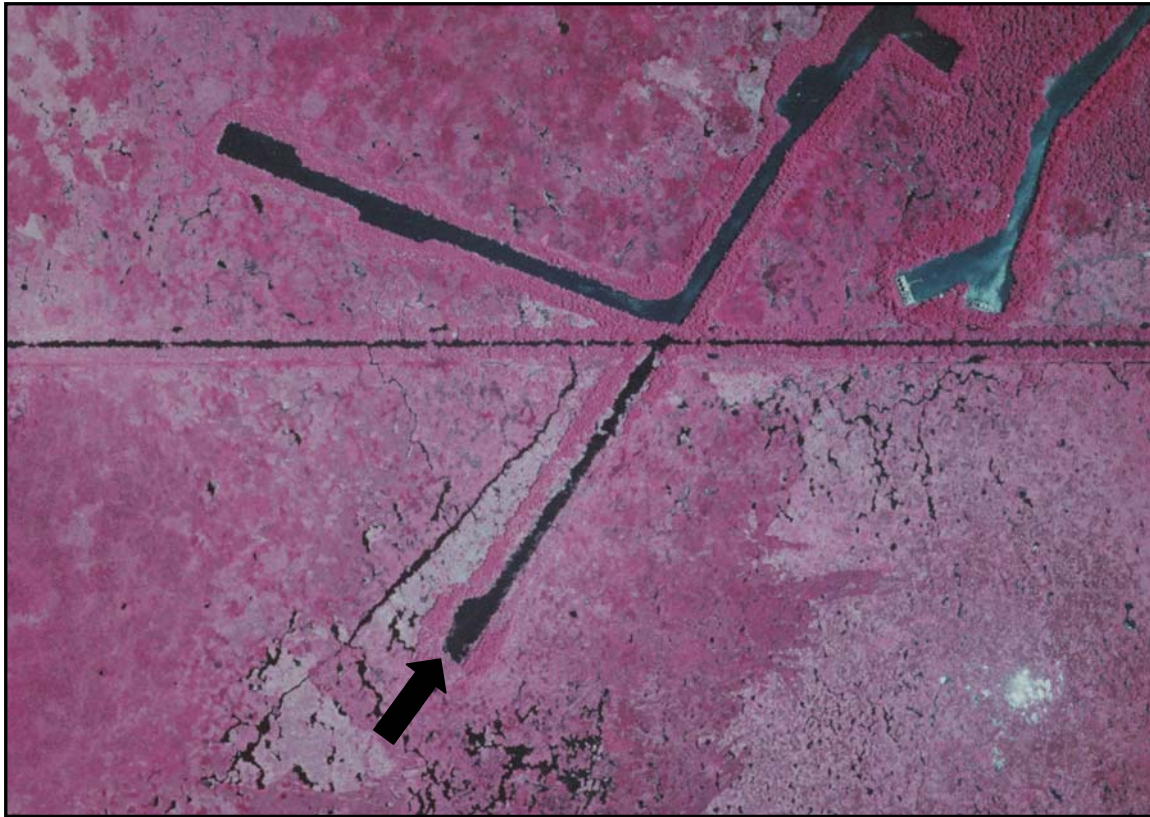
Spoil Banks. The spoil bank on the southeast side of the canal were taken down to marsh elevation over most of its area, but the northwest side of the canal and the turning basin had elevated spoil that harbored spoil vegetation and trees. The elevated portions of spoil contained species such as: Black Willow (*Salix Nigra*), Chinese Tallow (*Sapium sebiferum*), Groundsel Bush (*Baccharis halimifolia*), Palmetto (*Sabal minor*), and Brambles (*Rubus sp.*). The lower elevation spoil area contained species similar to the marsh such as: Alligatorweed (*Alternanthera philoxeroides*), Bull-tongue (*Sagittaria lancifolia*), Common Three-square (*Schoenoplectus americanus*), Sawgrass (*Cladium jamaicense*), Marshhay Cordgrass (*Spartina patens*), and Marsh Morning Glory (*Ipomoea sagittata*).

Figure 62. An infrared image of the Iberia Canal backfilled canal, noted by the arrow, taken in 2000.

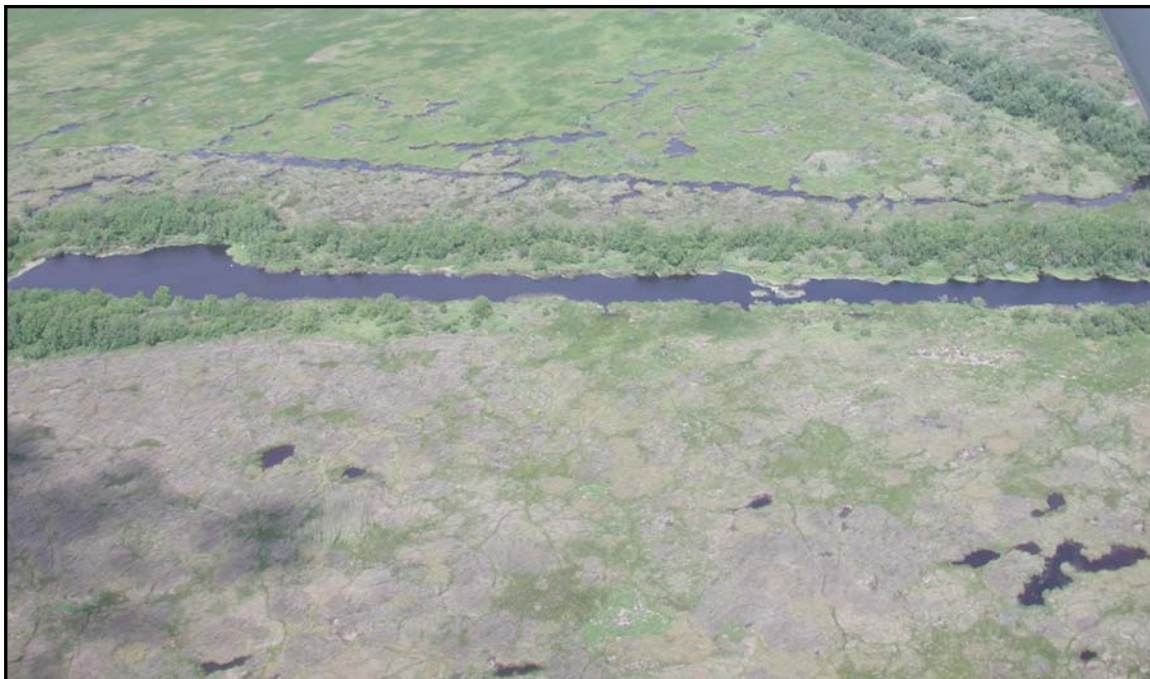
Figure 63. The Iberia Canal backfilled site in April 2004.

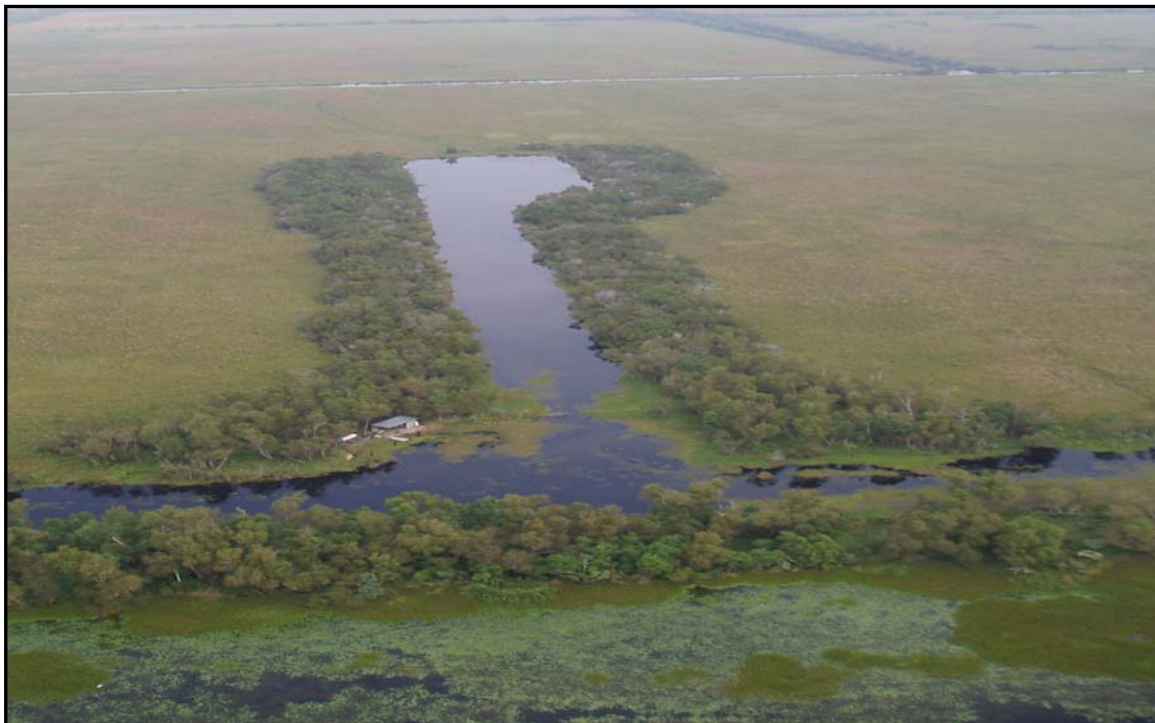
No ground evaluation was conducted at this site because of restricted access, and private hunting leases. From the air, this site appears to never have been backfilled. Trees line the entire spoil bank, except for at the extreme northern end of the turning basin. The canal is located in a failed agricultural area that has since returned to marsh, but the original agricultural drainage canals are visible.

Figure 65. The Delta Farms backfilled site in October 2004.

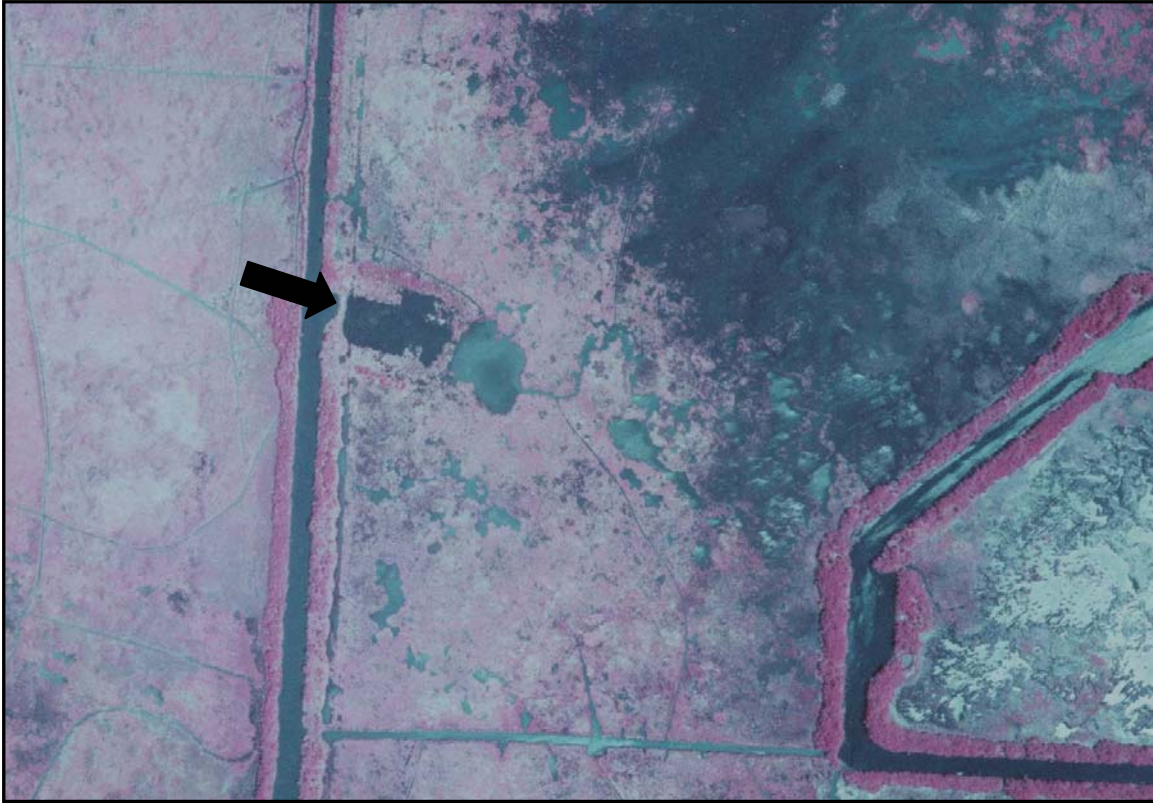
Spoil Banks. The spoil banks were a combination of marsh vegetation, elevated spoil and shallow water. The elevated spoil occurred on the north and south spoil banks along the outside of the former spoil areas. The vegetation on the elevated portions contained Chinese Tallow (*Sapium sebiferum*), Roseau Cane (*Phragmites australis*), Groundsel Bush (*Baccharis halimifolia*), and Brambles (*Rubus sp.*). There was open water on the northern spoil bank and it contained submerged aquatic species similar to the canal. The portions of the canal leveled to marsh elevation were covered with emergent marsh vegetation, predominately Marshhay Cordgrass (*Spartina patens*), Giant Cutgrass (*Zizaniopsis miliacea*), and Roseau Cane (*Phragmites australis*).

Marsh. The canal was in an area of brackish marsh with moderate oil and gas activity in the Paul J. Rainey Wildlife Refuge. Immediately to the east of the canal was a pond that nearly equaled the area of the canal, and the rest of the canal was surrounded by nearly 100% cover of Marshhay Cordgrass (*Spartina patens*).

Figure 66. An infrared image of the Rainey Refuge backfilled canal, noted by the arrow, taken in 2000.

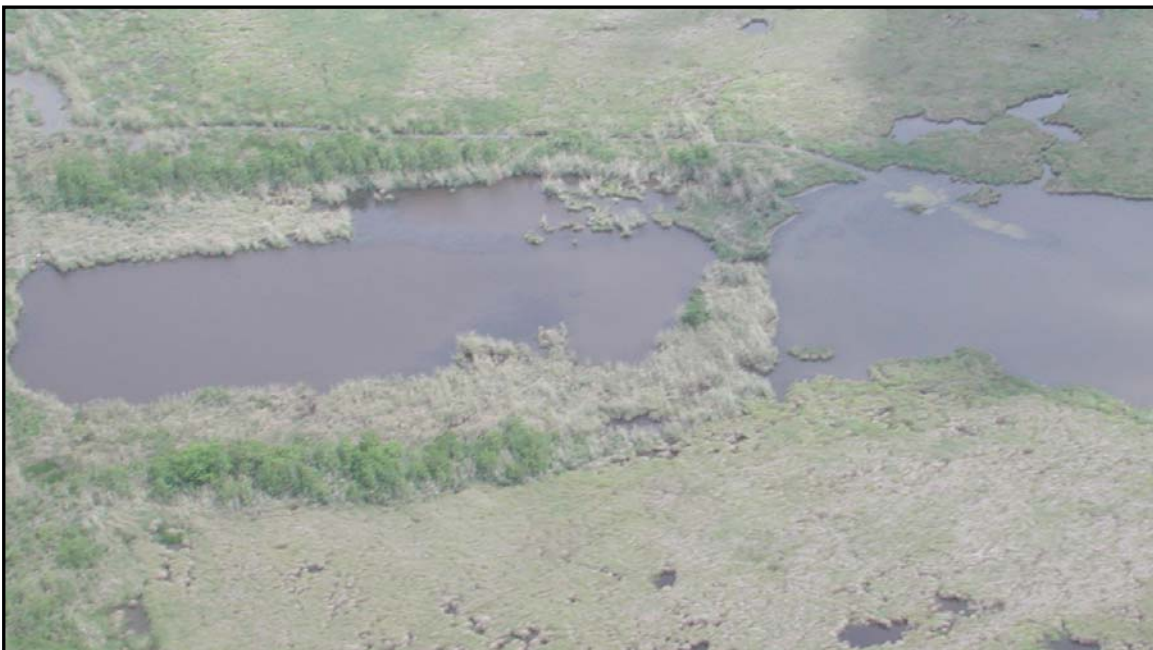
Figure 67. The Rainey Refuge backfilled site in April 2004.

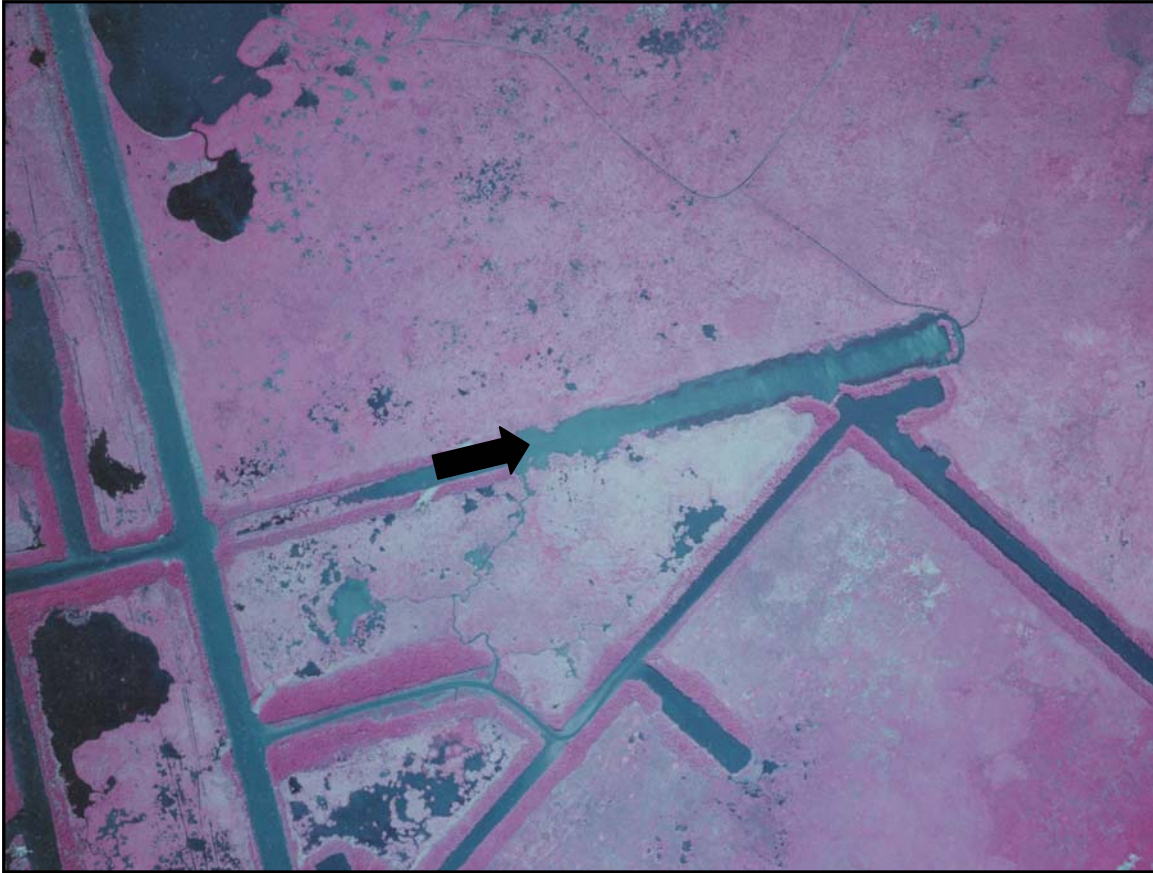
This site was only visually inspected, and no soil cores vegetation surveys, or depth profiles were taken. The spoil banks along the canal were backfilled to below marsh elevation, and remained shallow water. The canal contained submerged aquatic vegetation.

Figure 68. An infrared image of the Pecan Island East backfilled canal, noted by the arrow, taken in 2000.

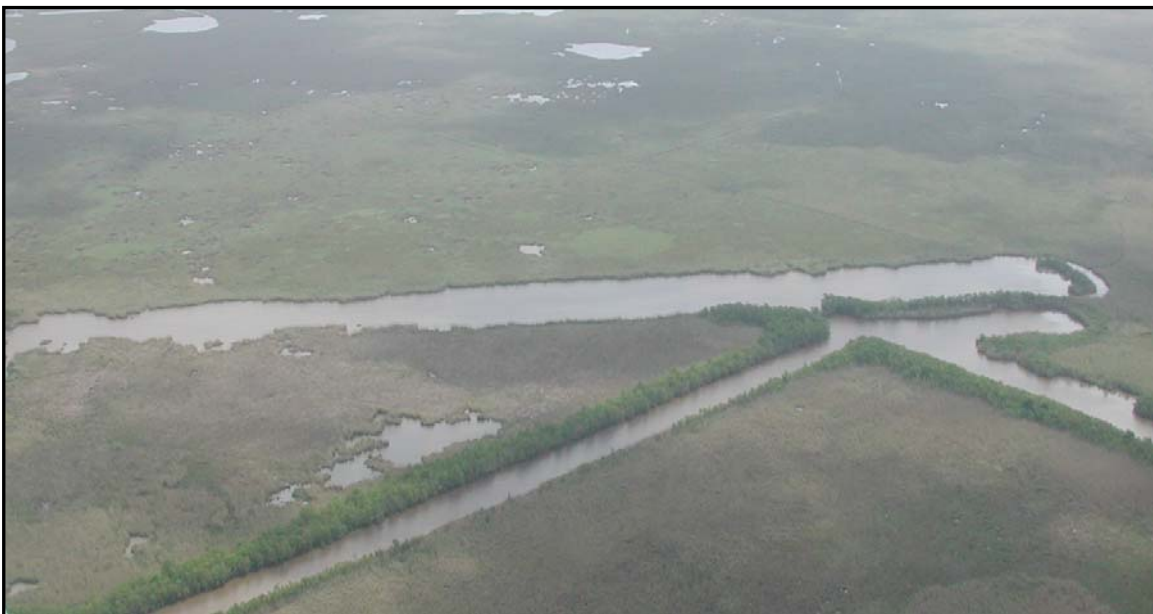
Figure 69. The Pecan Island East backfilled site in April 2004.
