Restoration success of backfilling canals in coastal Louisiana marshes

RESTORATION SUCCESS OF BACKFILLING
CANALS IN COASTAL LOUISIANA MARSHES

A Thesis

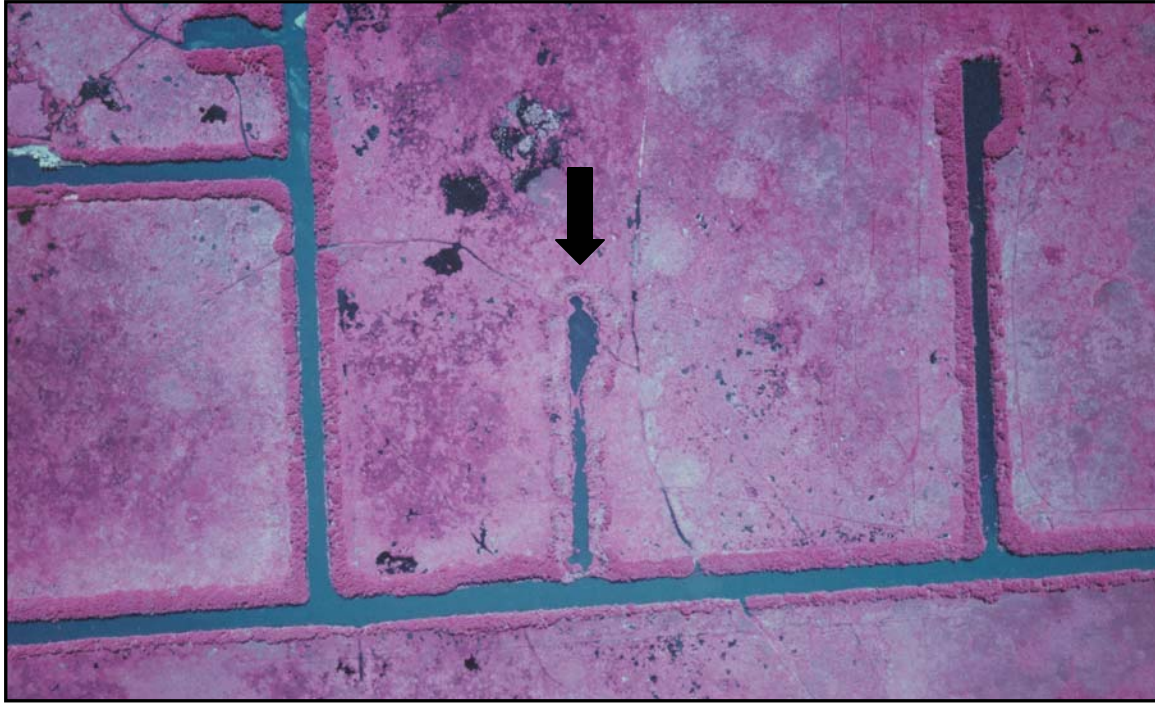
Spoil Banks. The back edge of the spoil bank was incompletely filled, and elevated spoil remained. The elevated spoil harbored species such as Chinese Tallow (*Sapium sebiferum*), Groundsel Bush (*Baccharis halimifolia*), Black Willow (*Salix nigra*), and Marsh Elder (*Iva frutescens*). The inner portions of the spoil bank were effectively leveled to marsh elevation and harbored emergent marsh vegetation. The dominate species were Marshhay Cordgrass (*Spartina patens*), Common Three-square (*Schoenoplectus americanus*), with traces of Bulrush (*Schoenoplectus californicus*), Cattails (*Typha* sp.), Roseau Cane (*Phragmites australis*), Giant Cutgrass (*Zizaniopsis miliacea*).

Marsh. The canal was in an area of fresh to intermediate marsh with few ponds, moderate oil and gas activity, and a variety of vegetation. The marsh consisted of 50% Marshhay Cordgrass (*Spartina patens*), 40% Common Three-square (*Schoenoplectus americanus*), and 10% Cattails (*Typha* sp.), with traces of Smartweed (*Polygonum* sp.), and Bulrush (*Schoenoplectus californicus*).

Figure 70. An infrared image of the Superior Canal backfilled site, noted by the arrow, taken in 2000.

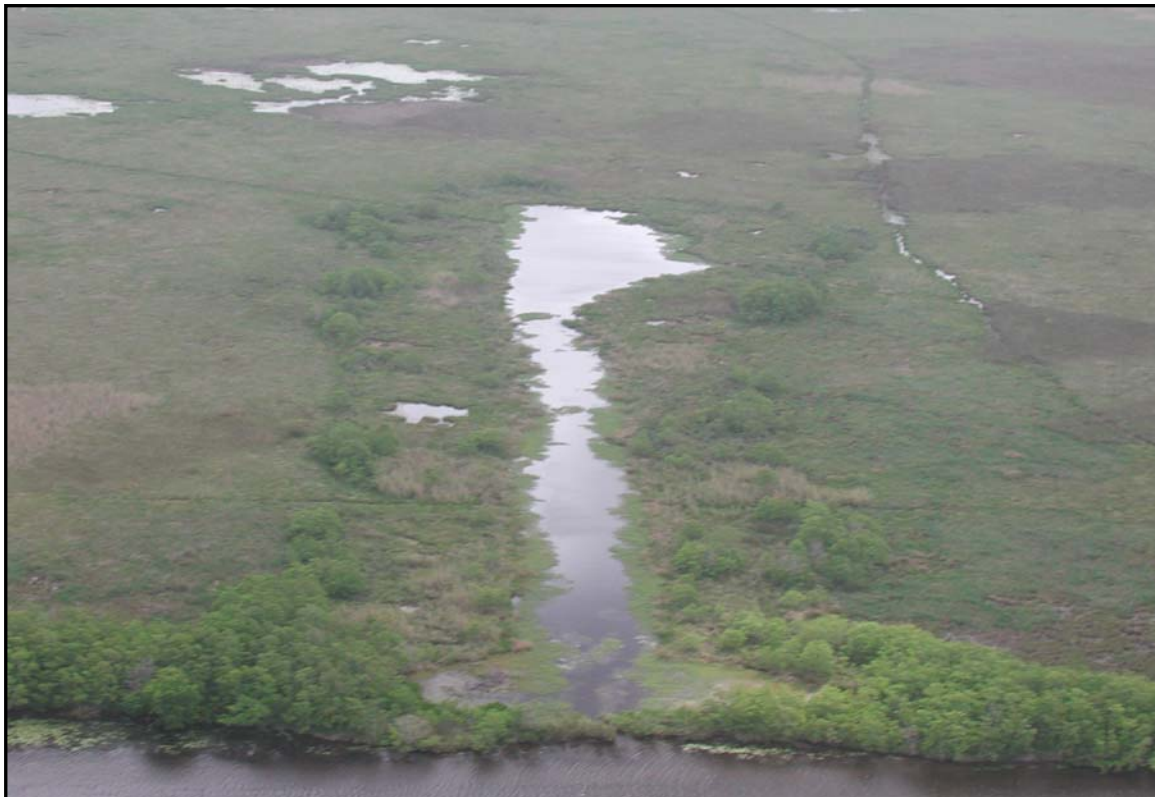
Figure 71. The Superior Canal backfilled site in April 2004.

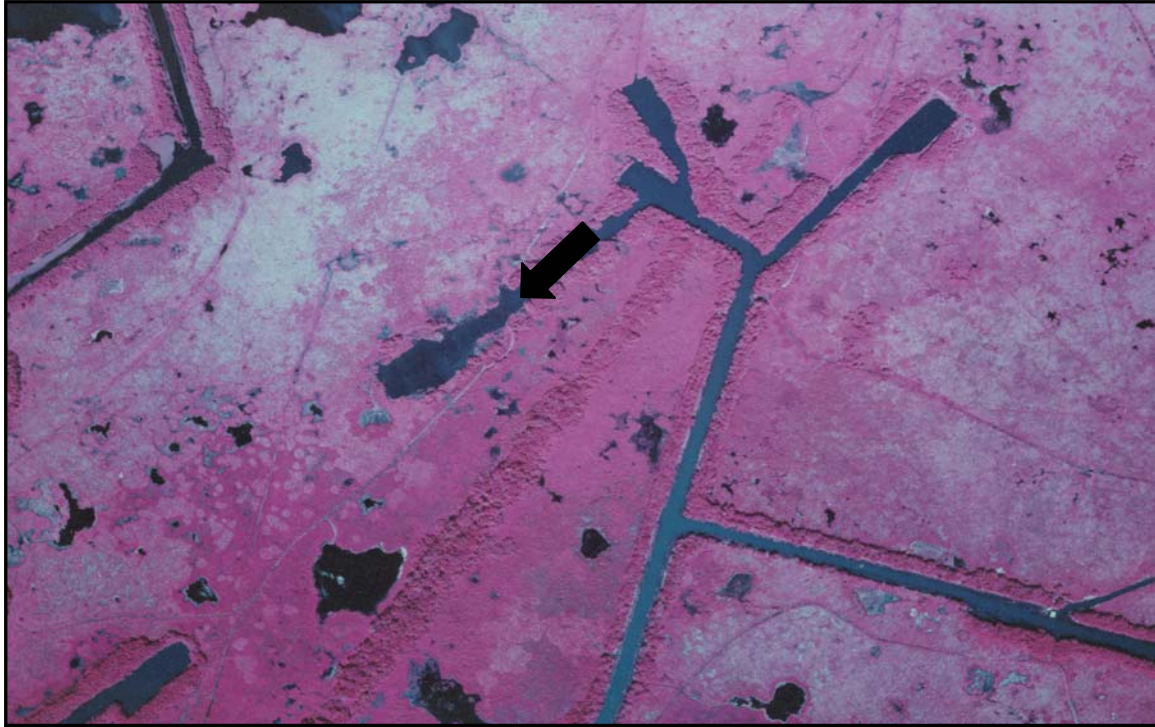
Spoil Banks. The spoil banks contained roughly equal areas of elevated spoil and marsh. The marsh has formed in areas that were originally dredged too deep and were left as open water. The elevated spoil areas were covered almost exclusively by Black Willow (*Salix nigra*).

Marsh. The canal was in an area of fresh marsh dominated by Cattails (*Typha* sp.), Bull-tongue (*Sagittaria lancifolia*), Marshhay Cordgrass (*Spartina patens*), and Smartweed (*Polygonum*).

Figure 72. An infrared image of the Long Island backfilled canal, noted by the arrow, taken in 2000.

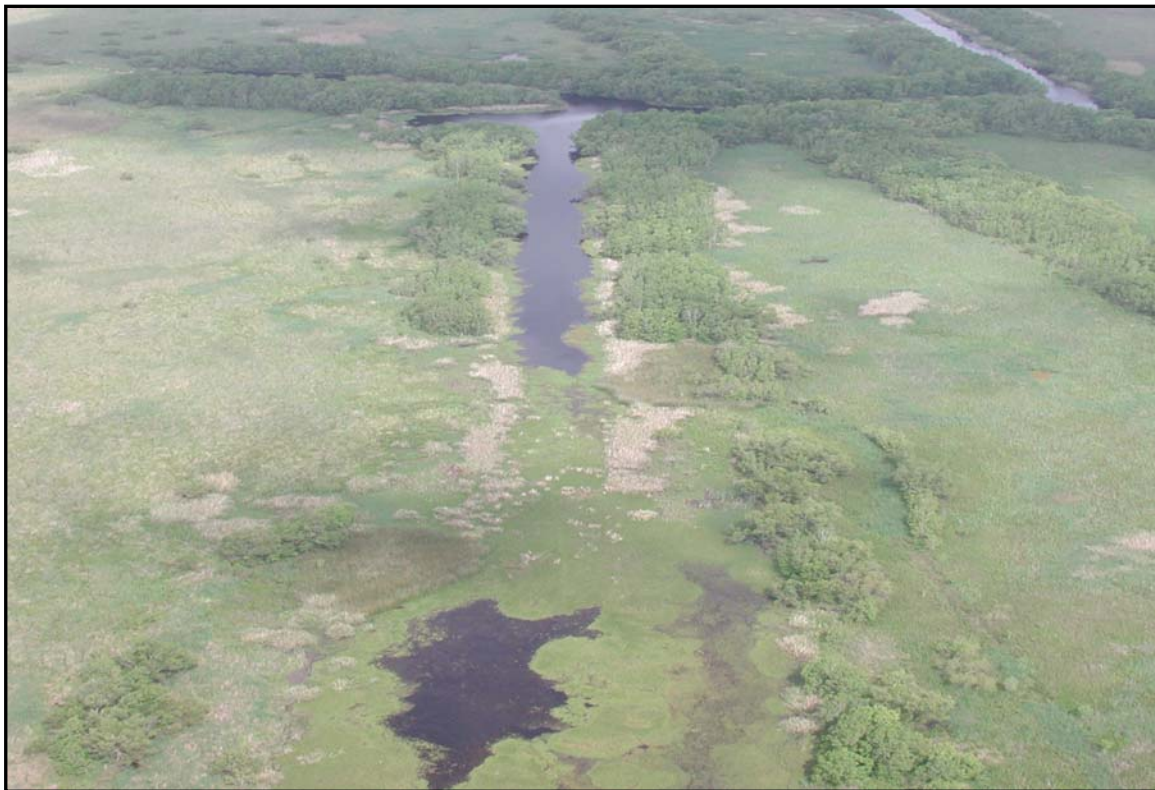
Figure 73. The Long Island backfilled site in April 2004.
