Woodpecker Damage to Wooden Utility Poles.

Robert Louis Rumsey
Louisiana State University and Agricultural & Mechanical College

A Dissertation

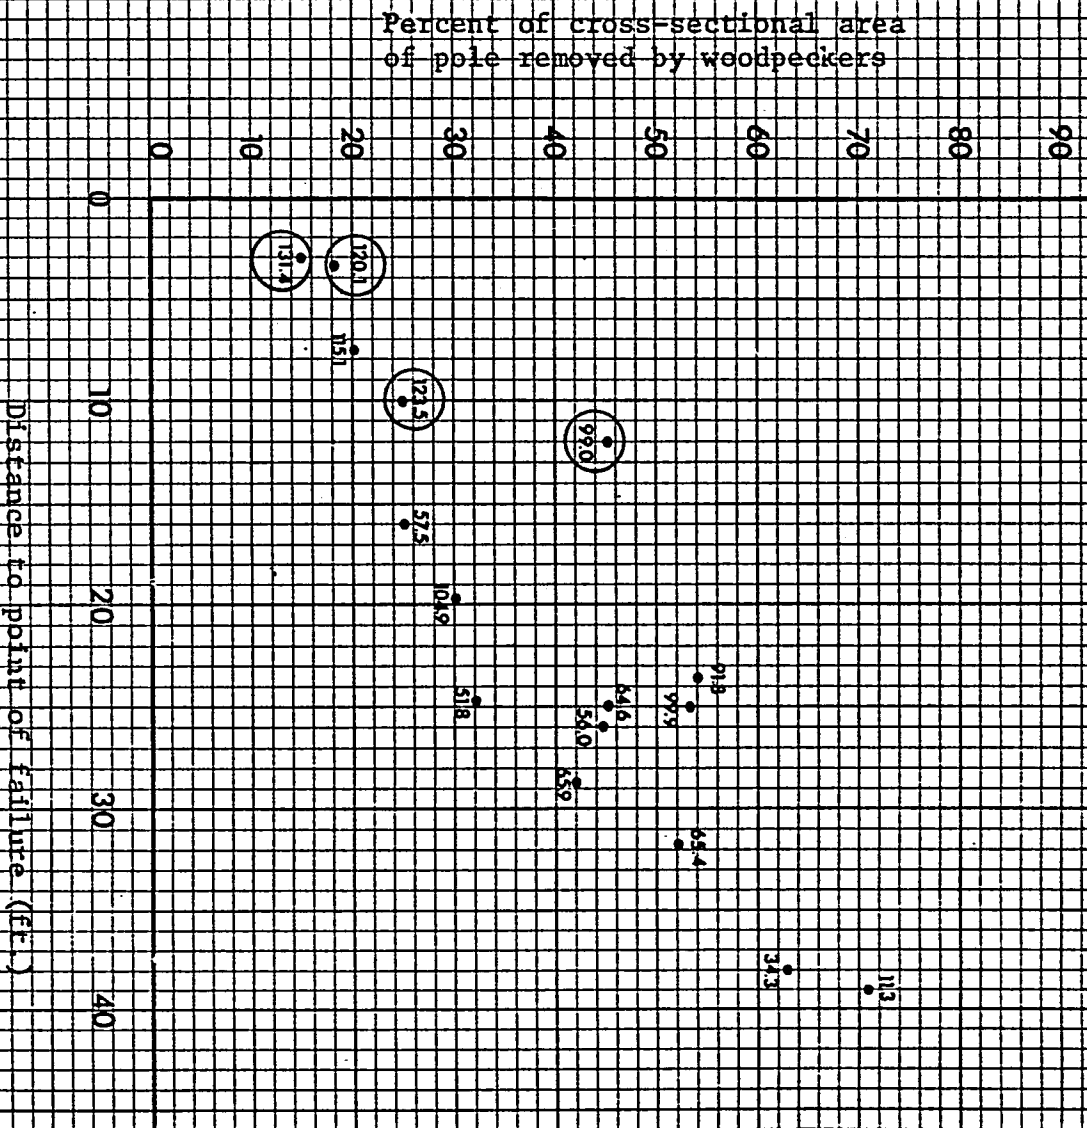
The relationship between distance from the ground to the point of failure, the amount of wood removed in cross-sectional area, and the percent of rated strength remaining at failure are shown in Figure 22. Since the sample was small ($n = 18$) and the woodpecker damage not of a predetermined size or height, correlations between the variables--amount of wood removed, distance from the ground to point of failure, and amount of strength left in the poles--are difficult to determine. However, certain conclusions can be made based on the data and information in the literature.

Damage near the top of a pole does not weaken it as much as when it is nearer the point of maximum stress, which is a few feet up from the groundline. For the four poles that broke below the woodpecker holes, the distances above groundline to points of failure were 3.0, 12.0, 9.8, and 3.4 feet, averaging 7.05 feet. All four of these poles had severe woodpecker damage. Pole #5121 had 17.2 percent of its cross-sectional area removed at 21.1 feet above groundline, pole 2112 had 12.3 percent at 25.8 feet, pole 4112 had 24.5 percent removed at 31.3 feet, and pole 2211 had 45.2 percent removed at 35.2 feet. And yet these four poles broke below the point of damage with an average force of 118.5 percent of the rating required to cause failure.

Figure 22. The relationship between percent of wood removed, distance to point of failure, and percent of strength remaining (based on NISC rating) in woodpecker damaged poles. Percent of rated strength at failure is ratio of applied force to NISC rating; these values are shown beside each plotted point. Poles with circles failed below woodpecker damage.

The two poles that broke with the least amount of force also had the largest amount of cross-sectional area removed. Pole 4121, with 72.2 percent of the wood removed, retained only 11.3 percent of its strength; pole 7122 had 62.7 percent wood removed and retained 34.3 percent of its strength. The configuration or shape of the woodpecker damage, hence the shape of the wood remaining, affects the strength. For instance, it is possible that the 27.8 percent of the wood remaining on pole 4121 would have caused a different strength value if the excavation around the center of the pole had a different distribution. The configuration causing the least reduction in strength would be a small opening with most of the wood removed from the center of the pole. This would resemble a hollow pipe with most of the circumference intact.

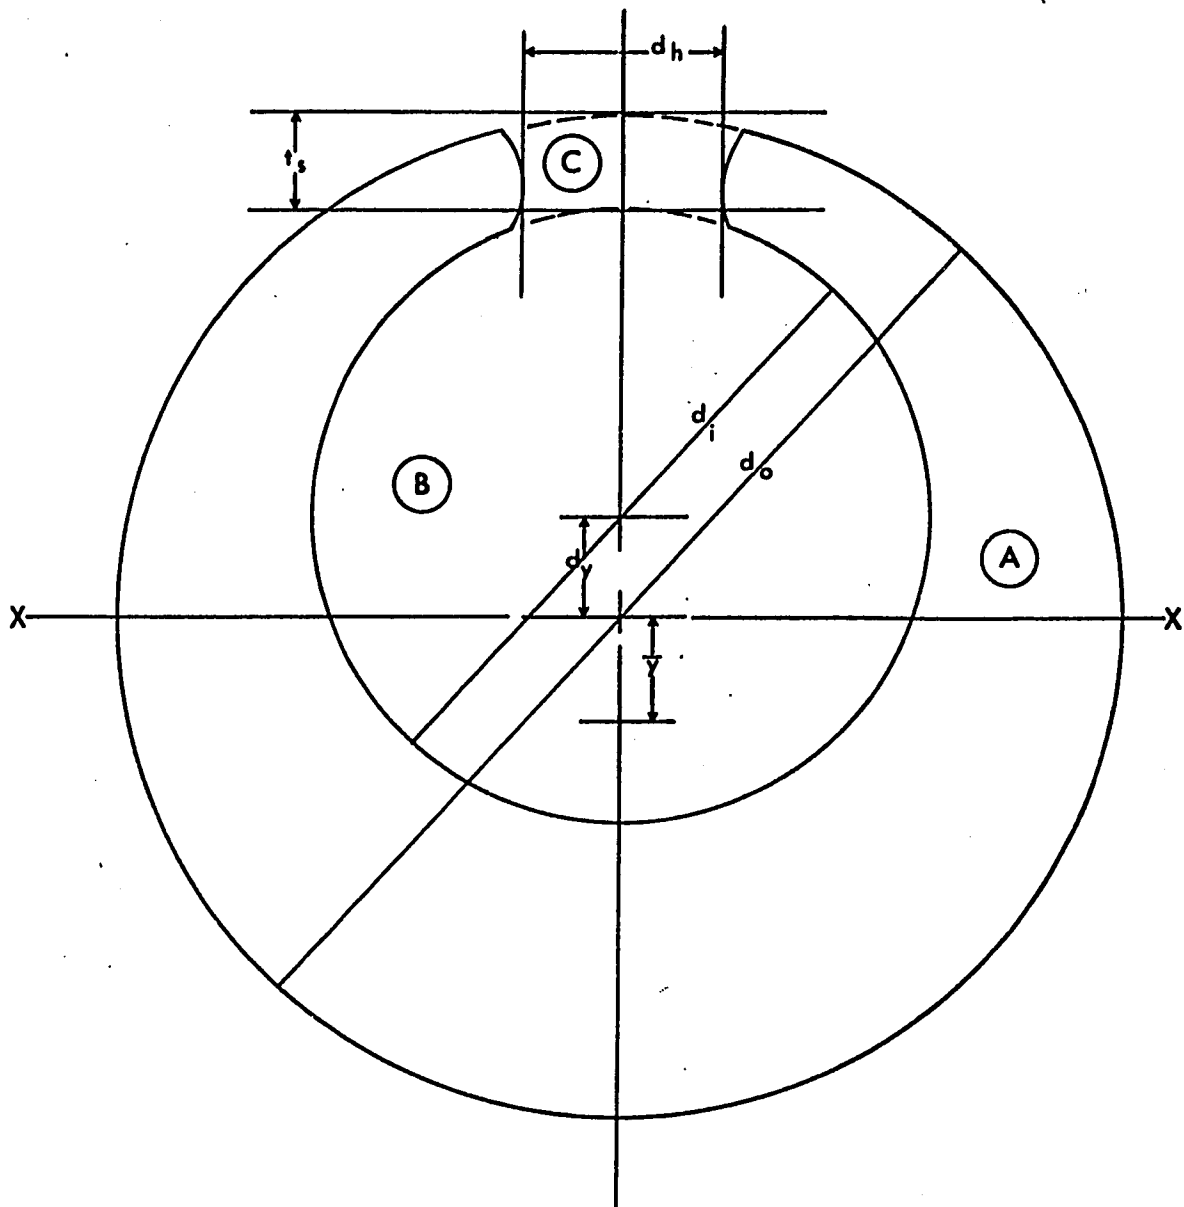
1. The pole is fixed in the ground and acts as a cantilever with a tapered section.
2. The cross section is homogeneous.
3. Lateral load is applied 2 feet below the apex of the pole.
4. The woodpecker nest cavity is approximated with a circle (area B in Figure 23) and a rectangle (area C, Figure 23).
5. The damage is assumed to be in the worst position around the circumference of the pole, i.e. consider it with most respect to the x-x axis (Figure 23).

Figure 23. Model used for calculating reduction of moment of inertia in a damaged pole.

The procedure which follows assumes that the damage reduces the moment of inertia of the pole and shifts the centroidal axis away from the center (Popov 1968). As an example, suppose a class 2, 50-foot pole contains woodpecker damage 23.5 feet from the apex. Measurements are (refer to Figure 23 for clarification):

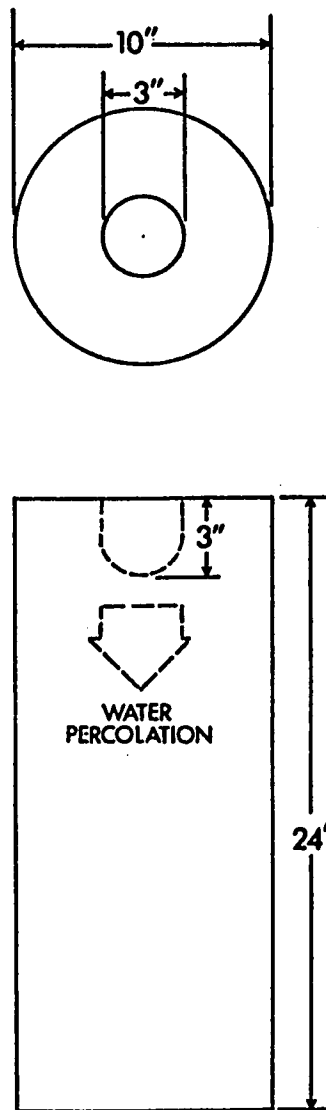
A test to evaluate further the rate and seriousness of decay in creosoted sections was conducted in a greenhouse. Twenty-four creosoted sections 8 to 12 inches in diameter and approximately 24 inches long were modified to resemble woodpecker damage. Cuplike depressions were chiseled out of one end of each section (Figure 24). On 12 sections a mixture of pentachlorophenol and oil was added at the rate of 0.5 pound of dry penta salts per cubic foot, based on the calculated volume of wood in the cylinder directly below the depression (denoted by arrow). Then two levels of water, 50 ml and 100 ml, were added to the 24 sections at weekly intervals

Figure 24. Cuplike depressions were chiseled out of creosoted sections and water added at weekly intervals to encourage decay.

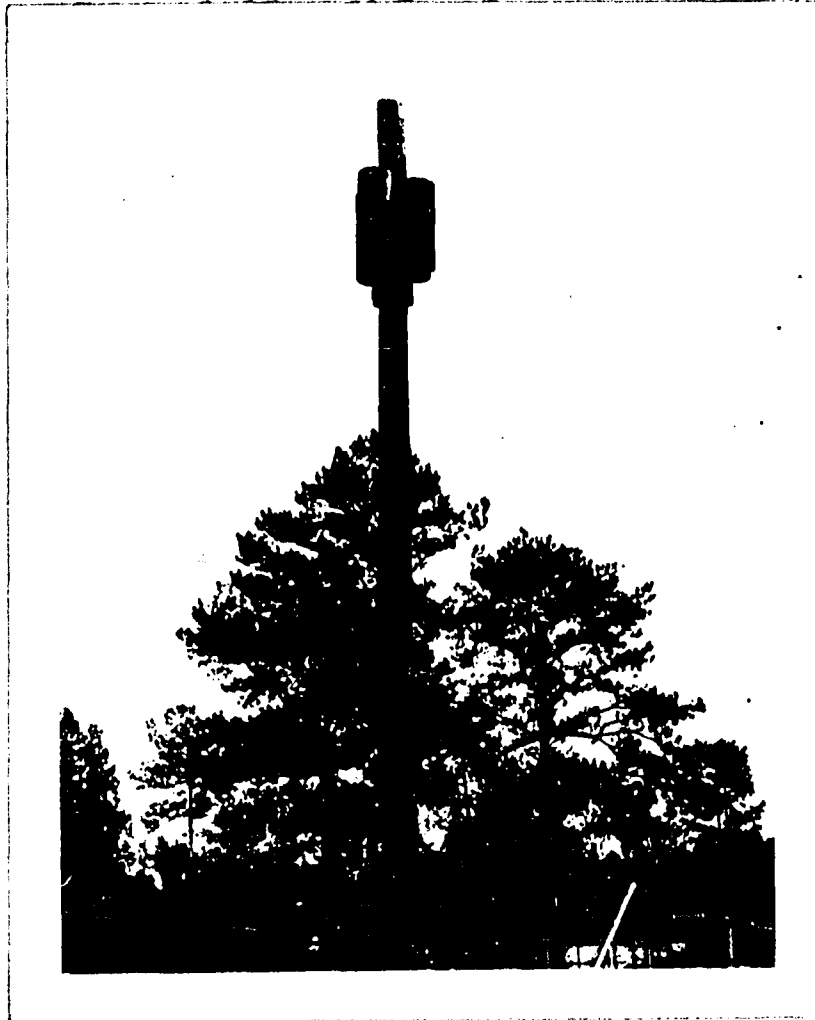
Results and discussion.--The amount of rainfall that entered the four cavities in 14 separate rainstorms, over a 4-month period from December 1968 through March 1969, was measured (Table 15). Amounts varied widely, depending on the aspect of the openings. Cavities facing 173° and 263° received the highest percentages of rainfall with over 70 percent of the total in three storms. During each of the 14 rainstorms, measurable amounts were caught in the south-facing cavity. There were only two instances when measurable amounts were not caught in the west cavity. The east-facing cavity with an azimuth of 83° received essentially no rain, and the one facing 353° (north) received token amounts.

Figure 25. Four simulated woodpecker cavities used to catch rainfall. (Alexandria Forestry Center, Rapides Parish, Louisiana, 1969.)

It was evident that rainfall gets into some woodpecker cavities-- certainly those facing the direction of the prevailing rainstorms. Wood must have about 15 percent moisture content (based on oven-dry weight) before decay can begin, and 25 to 32 percent for decay of consequence (Boyce 1961, p. 344). Probably ample moisture to cause decay enters the cavities, but the length of time the wood is maintained at a high enough moisture content to support fungal activity is not known.
