## Investigation of Best Practices For Maintenance Of Concrete Bridge Railings

# INVESTIGATION OF BEST PRACTICES FOR MAINTENANCE OF CONCRETE BRIDGE RAILINGS

A Thesis

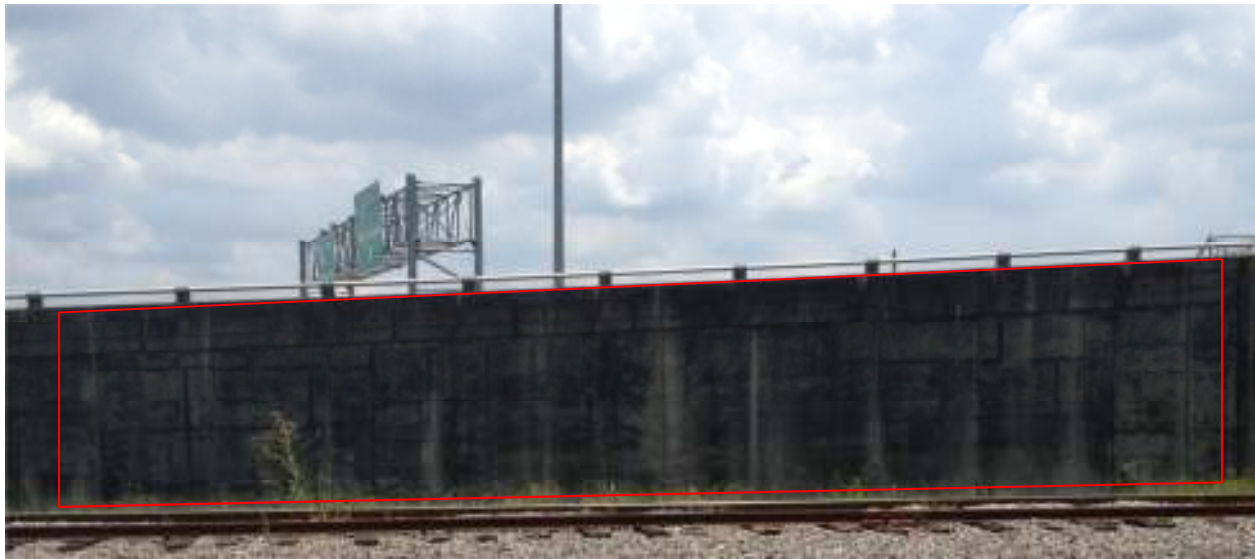
Figure 1  
Development of Biofilms on Concrete Structures in Louisiana

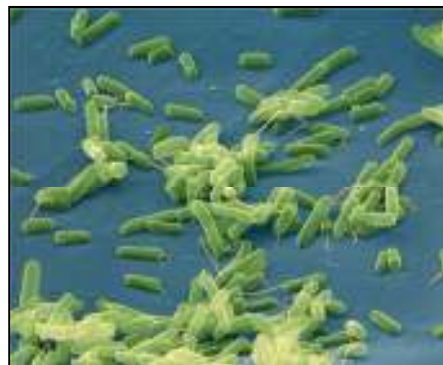
Figure 2  
Microscopic Image of Bacteria (Mckinney 2009)

Bacteria are very small organisms with sizes usually smaller than one micron (1 $\mu$ m) (Sanchez-Silva and Rosowsky 2008). These are unicellular (one cell) organisms whose genetic materials are not contained in a nuclear membrane as shown in Figure 2. They are also known as “prokaryotes”. Bacteria can create formations like chains, pairs, clusters, and other groupings. The reproduction of bacteria is a simple process of division called binary fission, where a bacterium subdivides into two equal daughter cells (Tortora et al 2004).

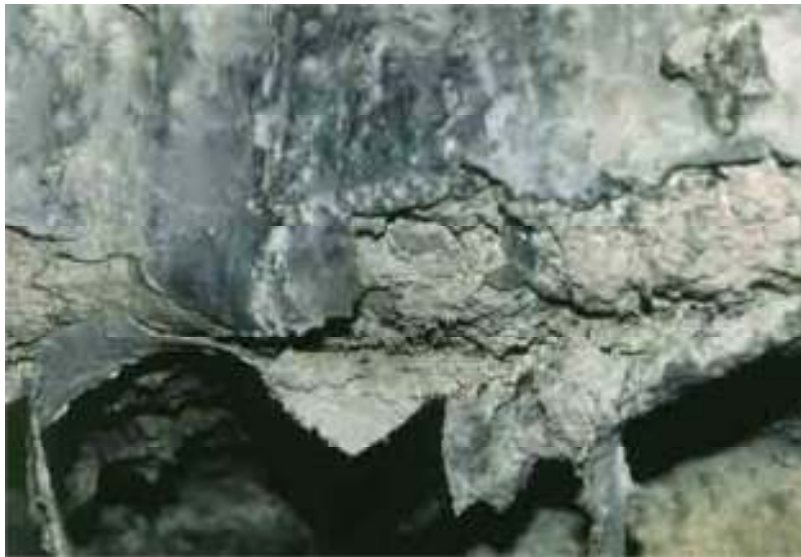
Figure 3  
Acid Producing Bacteria Penetrating and Colonizing Concrete (Linabond Eurasia Limited)

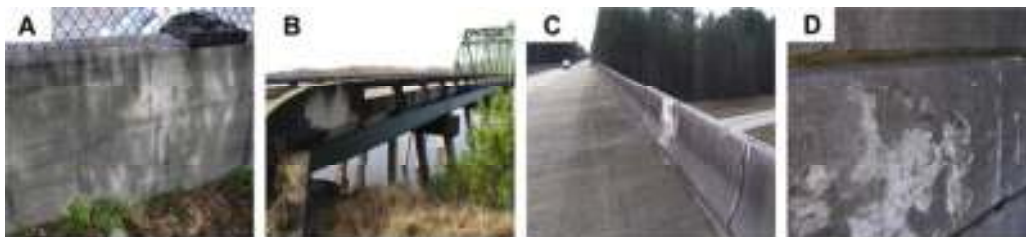
Figure 4  
Concrete Damage Caused by Fungi (Giannantonio et al. 2009)

Fungi are different from plants; while plants get their nutrients through photosynthesis, fungi absorb nutrients from the substrate on which they grow, by secreting enzymes that breakdown cellulose material around them. Just as bacteria, fungi can be found under a wide range of climatic conditions. However, fungi accounts for a larger fraction of the biomass of the planet than humans (Ray and Hanks 2012). That is why humans always come in contact with different species of fungi. Out of approximately 100,000 species of fungi that have been identified, only several hundred can produce mycotoxins, which are toxic compounds thought to be produced by the organism to defend itself (Ray and Hanks 2012). Figure 4 shows concrete damage caused by fungi.

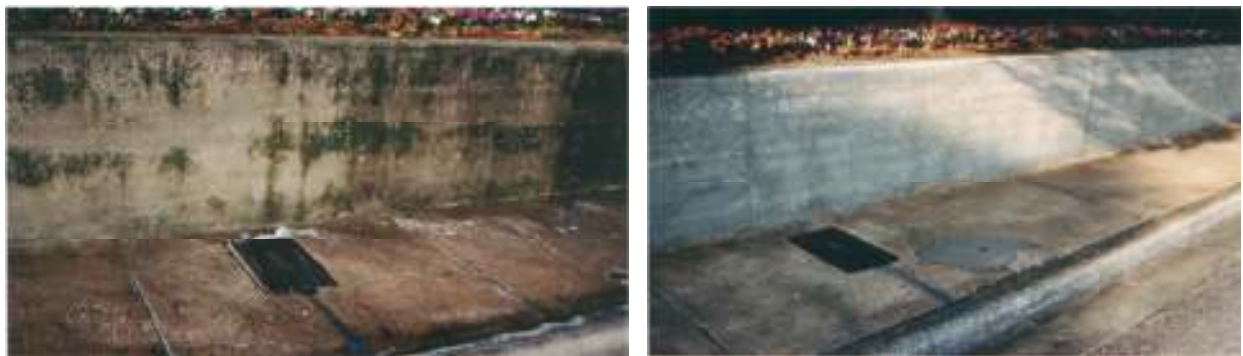
Figure 8  
Concrete colonized by algal species (green algae); Before and After cleaning (Eco-Wares)

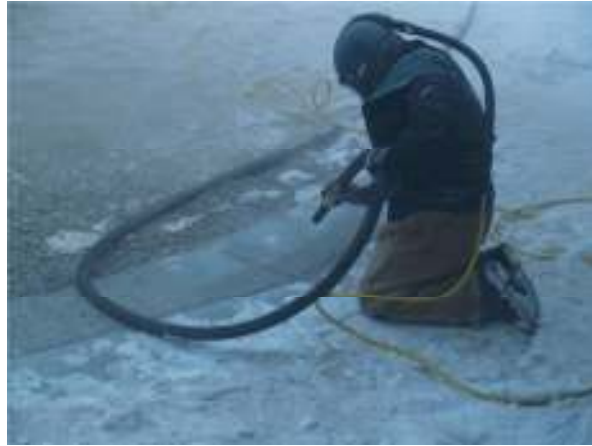
Figure 17  
Abrasive Blasting (Eye On Sandblasting & Painting Ltd.)

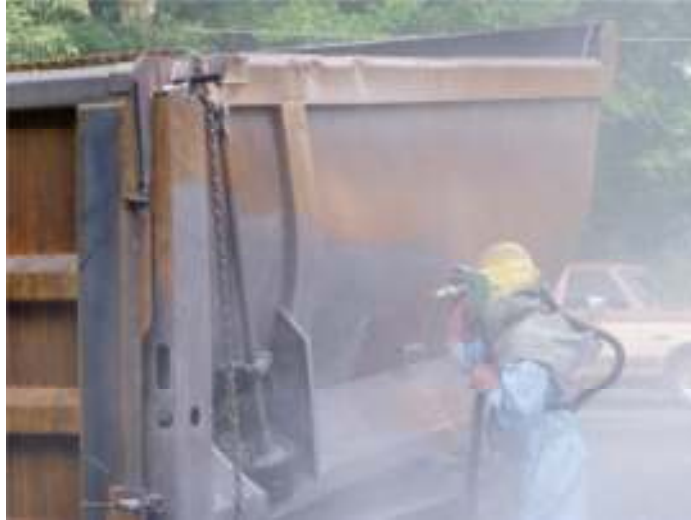
Soda blasting of a steel container prior to repainting (Mid atlantic sods dry ice blasting 2012)

Soda blasting shown in Figure 18 is an abrasive but gentle cleaning method that is increasing in popularity. The process involves the use of Sodium Bicarbonate ( $\text{NaHCO}_3$ ) as the cleaning medium, applied against a surface using compressed air. This method is very effective for cleaning surfaces, paint stripping, automotive restoration, industrial equipment maintenance, rust removal, graffiti removal, masonry cleaning, and boat hull cleaning. Soda blasting became very popular in the early 1980s when it was selected by the engineers of the state of New York to clean the Statue of Liberty without causing any harm to its exterior. Other methods such as sand blasting were discarded because they could cause damage to the materials of the Statue of Liberty (Pickard 2012).

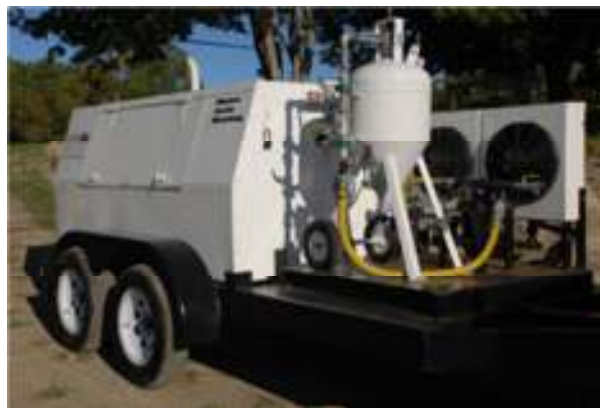
Figure 19

The equipment used to perform soda blasting operations is called soda-blaster and is shown in Figure 19. The soda-blaster consists of a blast generator, high pressure compressed air, moisture decontamination system, blast hose, and a blast nozzle (Pickard 2012).

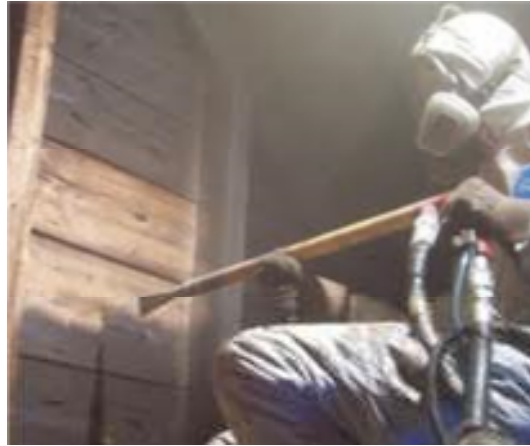
Figure 20  
Dry-Ice blasting process (Pure Air Systems 2012)

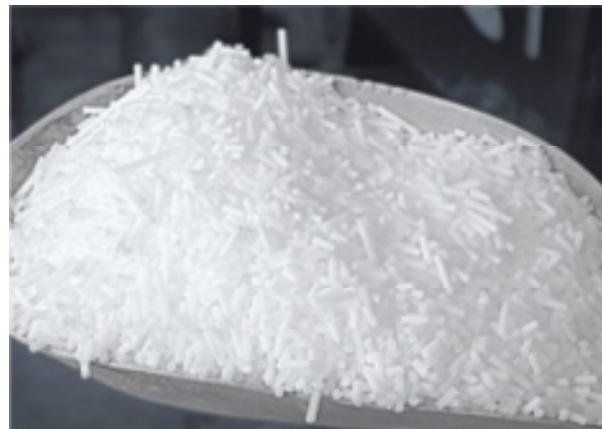
Figure 21  
Dry-Ice blasting medium (pellets)  
(American Society for Testing and Materials 1997)

Dry ice blasting shown in Figure 20 uses CO<sub>2</sub> as the blasting medium. Carbon dioxide shown in Figure 21 is a non-poisonous, liquefied gas, which is relatively cheap when compared to the other blasting materials. One of the advantages of this method is that it is

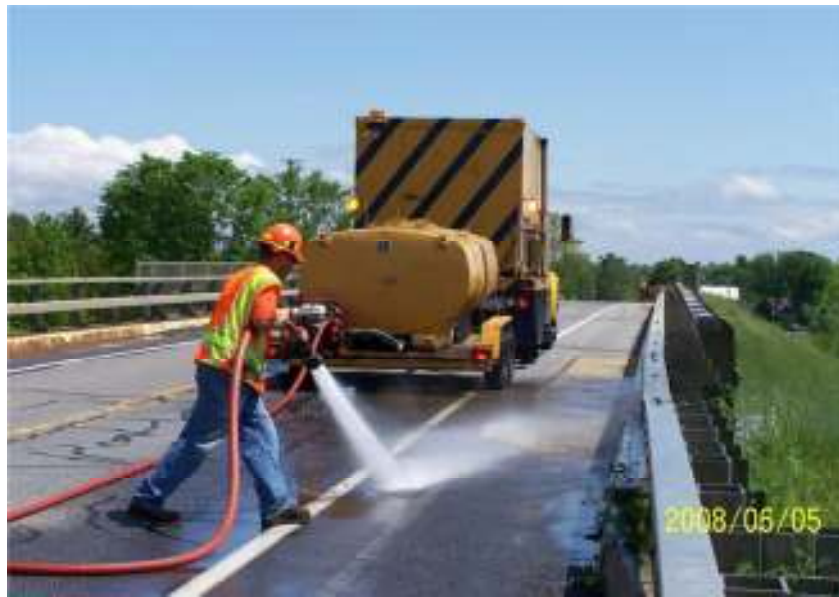
Pressure washing shown in Figure 22 is a method that is used in order to remove contaminants from surfaces. The process consists in pumping water at high pressures against a surface to remove dirt, paint, coatings, or any other undesired loose particles. It is a common

practice for highway maintenance agencies to implement this method in order to clear their roads and bridges from debris, dirt, grease, and contaminants. The New York State Department of Transportation employs this cleaning technique in their bridges and roads to either clean the surface, or to prepare the surface for the application of sealants or coatings (New York State Office of Structures 2007; NY Office of Transportation Maintenance 2008)

Pressure washing of a concrete deck (NY Office of Transportation Maintenance 2008)

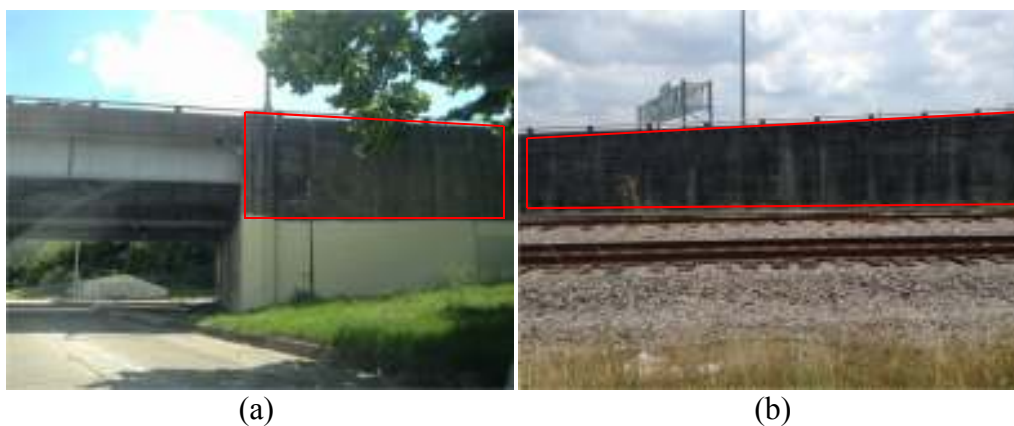
Figure 29  
Biofilm Sites in Louisiana

The development of biofilms on concrete structure (layer of mildew, mold, bacteria, fungus, yeasts or any combination) has a negative impact not only due to aesthetic reasons but also due to its influence on the performance and integrity of the structure (Adamo and Violante 2000; Bastidas-Arteaga et al. 2008; Bott 2011; de la torre et al. 1992). Biofilms develop easily when the right conditions are present, such as high relative humidity (60 to 98%) and temperature (70 to 95°F). These conditions are encountered in the hot-humid climatic region, which includes the state of Louisiana (Department of Energy 2010). As a consequence, visible stains and a relatively fast deterioration of bridges, roads, highways, and other structures are encountered in Louisiana. This issue has triggered public complaints, which as a result have supported the need to find a practical and economic solution to be adopted by the Louisiana Department of Transportation and Development (LADOTD) to address biofilm issues. Figure 29 (a and b) presents concrete elements in Louisiana that show clear signs of biofilm activity, characterized by the black stains.

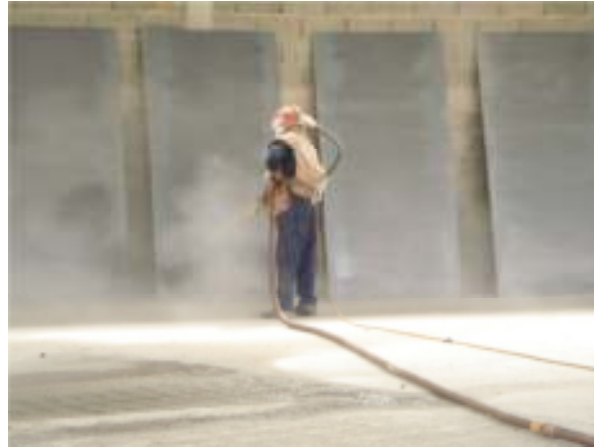
Figure 31  
Sand and Soda Blasting

Abrasive blasting, shown in Figure 31, is commonly known as *sandblasting*. This is a process that consists of propelling a stream of abrasive materials towards a given surface at high pressure in order to clean it from contaminants, remove paints and coatings, smoothen or roughen the surface, or even shape it (American Society for Testing and Materials 2012). Compressed air or centrifugal wheels are the most common mechanisms to propel the blasting media. There are several variants of this process, such as shotblasting; which uses copper, zinc, aluminum, and steel as the blasting medium, dry ice blasting; which employs CO<sub>2</sub> pellets, bead

blasting; which uses glass particles as the blasting medium, sandblasting; which employs sand (silica) as the blasting method, but has been related to lung problems, and soda blasting; which uses Sodium Bicarbonate ( $\text{NaHCO}_3$ ) as the blasting media.
